REPORT OF SUBSURFACE EXPLORATION AND
GEOTECHNICAL ENGINEERING EVALUATION
Clarkston Lake Dam Reconstruction
Clarkston, DeKalb County, Georgia

WILLMER ENGINEERING, INC.
Willmer Project No. 71.3983

November 6, 2014

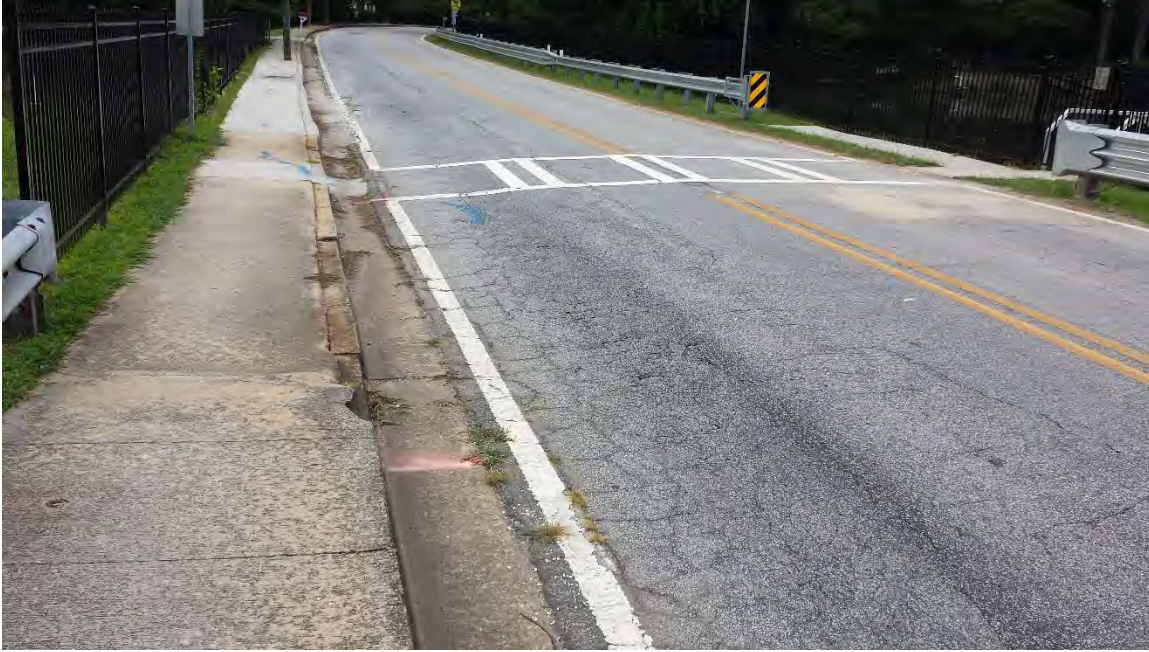
- The downstream slope is vegetated with shrubs near the west end and grass in the middle and the east end.
- The crest of the dam is approximately 35 feet wide with an active roadway (Norman Road) on top. The eastbound lane of Norman Road appears to have settled, forming cracks along the center of the lane (see Appendix III, Sheet 2).

Norman Road – Facing West: Settlement and Cracking

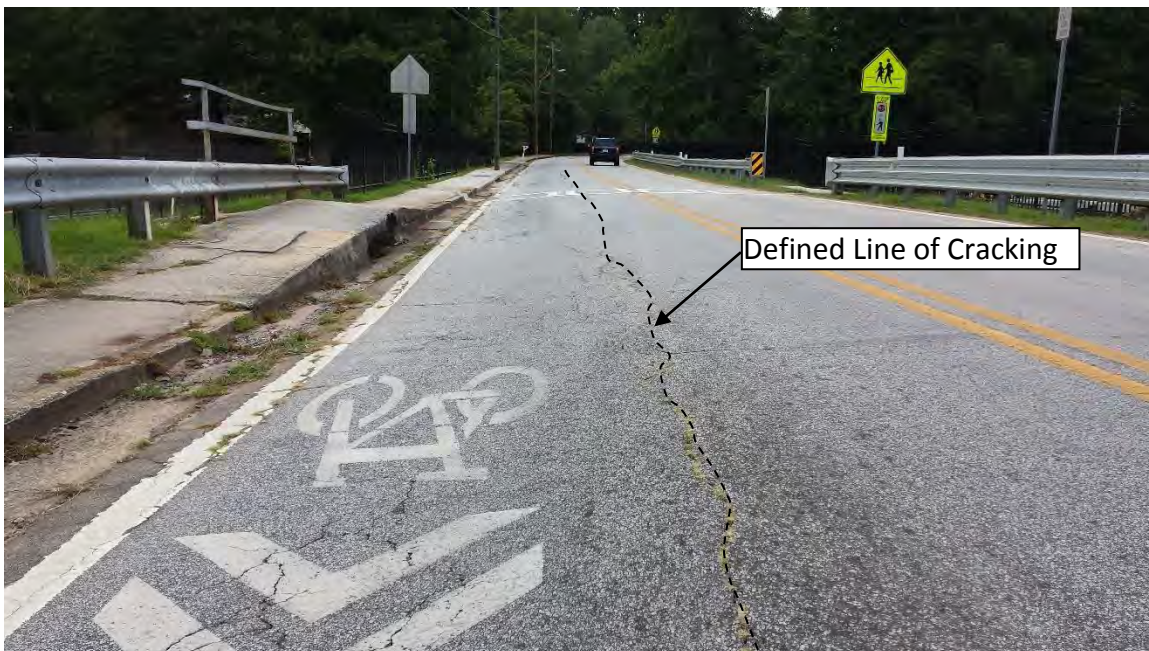
Norman Road – Facing West: Settlement and Cracking

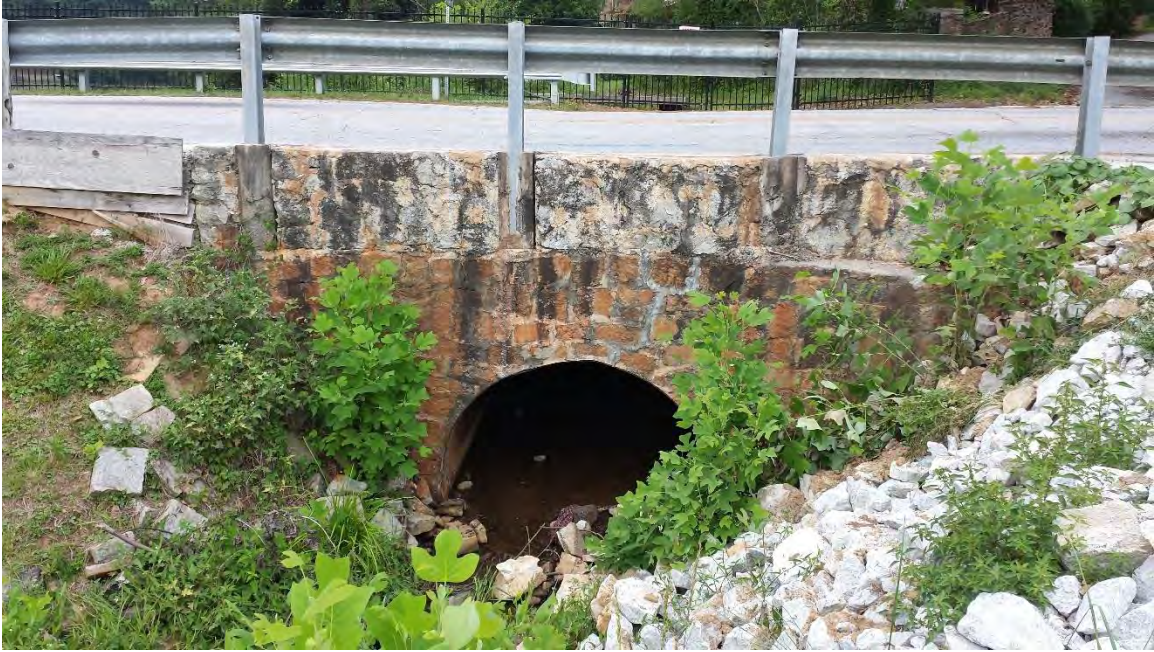
- The dam includes a spillway that appears to be a combined principal and emergency spillway located near the east end of the dam. The spillway consists of a 60-inch diameter corrugated metal pipe that crosses under Norman Road (see Appendix III, Sheet 3) and discharges into a riprap-lined channel that flows west along the toe of the dam (see Figure 2). The inlet structure is connected to the lake through a concrete flume (see Appendix III, Sheets 3 and 4); however, no flow was observed through this inlet flume during our site visit.

Principal spillway channel through corrugated metal pipe; Facing North

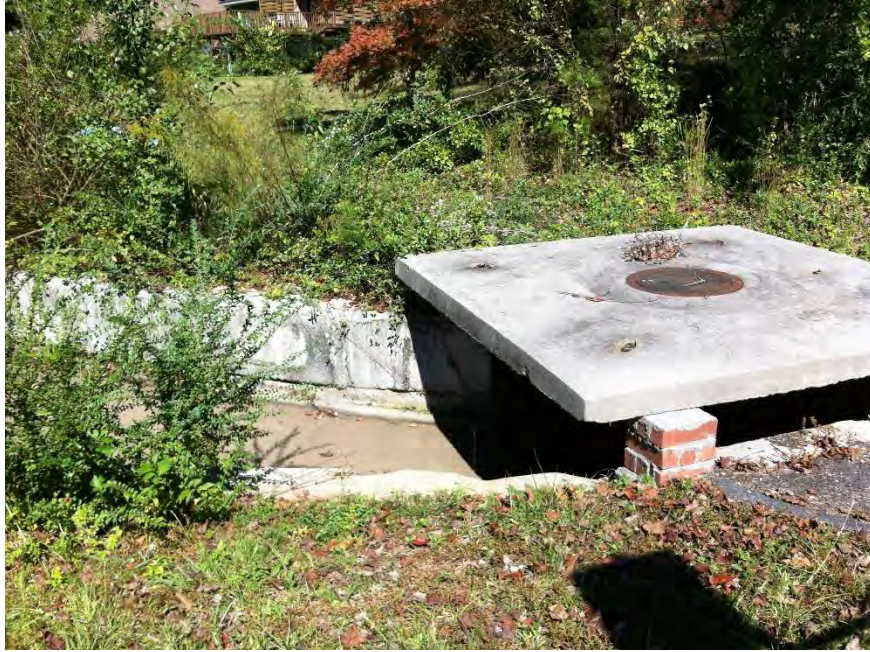
- In addition to the inlet flume, a concrete pipe (approximately 18-inches in diameter based on visual estimate; the structure is located inside a fence and was not accessible during our site visit) connected to the inlet structure was observed discharging steadily into the structure. The upstream end of this pipe could not be located.

Inlet Structure and Concrete Flume; Facing North

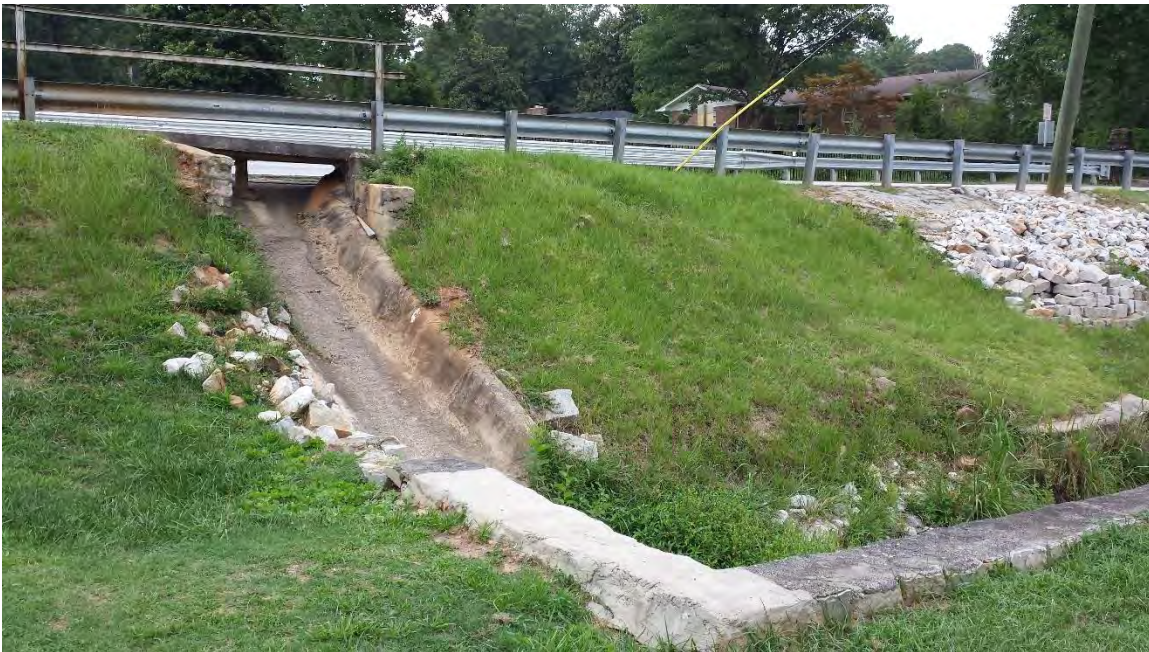
Emergency Spillway Flume; Facing Northeast

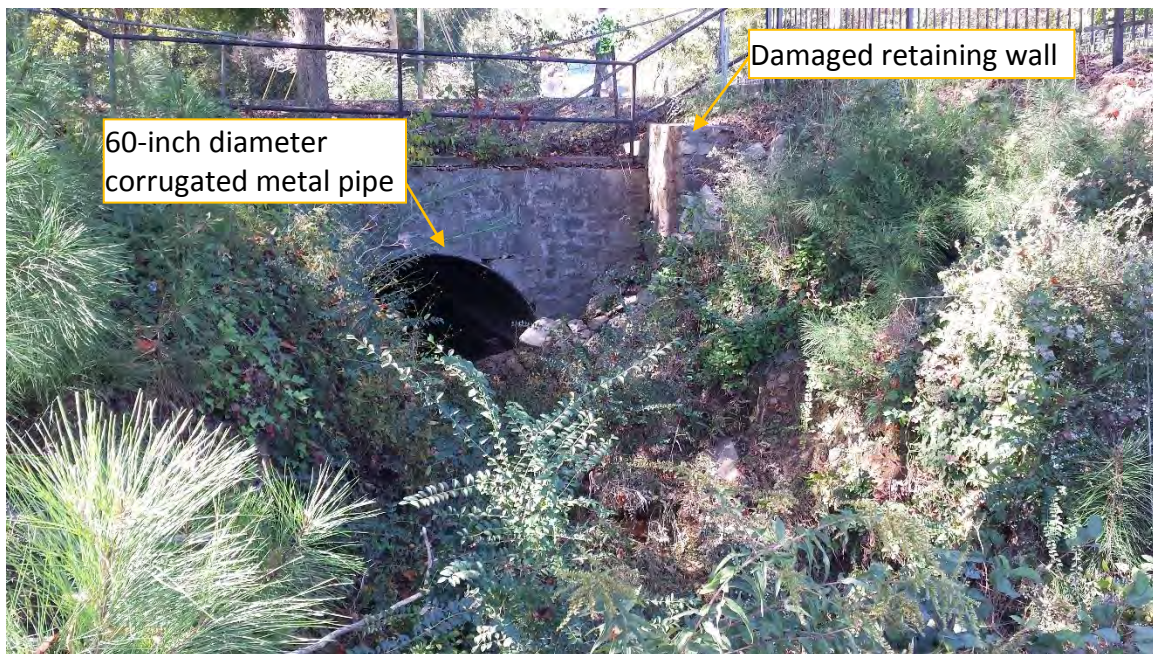
- A 60-inch diameter corrugated metal pipe culvert is located at the west end of the dam near the toe (see Appendix III, Sheet 5). The pipe runs to the west beneath the adjacent property; the upstream end of this pipe could not be located. No flow was observed in the pipe at the time of our visit.

Damaged retaining wall

60-inch diameter
corrugated metal pipe

Drainage Channel at the West End of Dam; Facing West

An alternative to constructing a retaining wall would be to extend the existing pipe culvert along the toe of the reconstructed dam. Fill can then be placed and compacted around the extended pipe to reconstruct a downstream slope of 2.5H:1V or flatter. A perforated drain pipe encased in drainage stone should be provided on the upstream side of the culvert pipe. Seepage from the dam will enter the drain pipe and flow to the inlet of the pipe that runs beneath the Milam Park ball fields. If this alternative is chosen, we recommend that two manholes be installed at each end of the extended culvert pipe to allow for visual inspection and future maintenance.

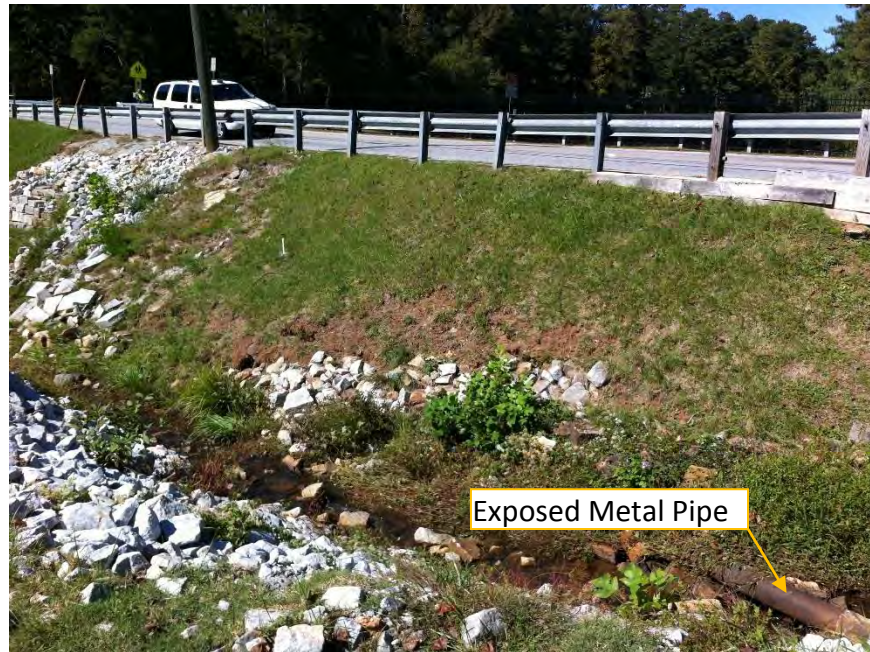
- Sloughing was observed on the slope near the toe of the dam (see Appendix III, Sheet 6).
- Riprap has been placed at two locations on the downstream slope of the dam. It appears that the riprap was placed to repair previous sloughs on the downstream slope (see Appendix III, Sheets 6).

Sloughing of Downstream Slope; Facing Northwest

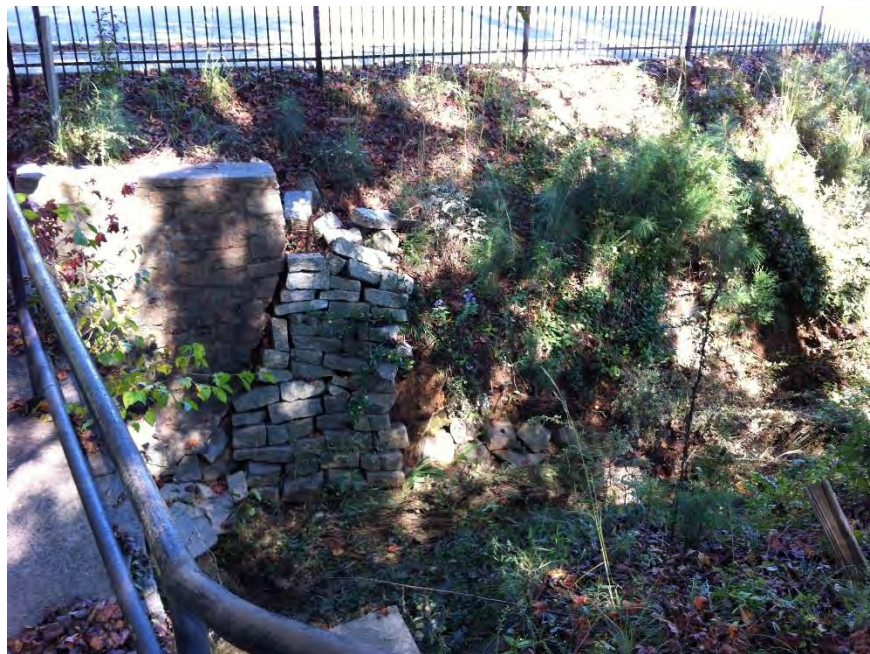
- A partially damaged retaining wall about 5 feet wide was observed at the west end of the dam (see Appendix III, Sheet 6). The downstream slope adjacent to the wall is very steep (estimated to be 0.7H:1V).

Damaged Retaining Wall, Steep Slope, and Sloughing at West End of Dam; Facing North

The individual SLIDE output sheets for the above analyses are presented in Figures 6A through 6D. As described earlier, the existing slope is steeper than 1H:1V near the west end of the dam, and because of the existing culvert under the driveway of the adjacent house and other site features, the slope of the dam cannot be flattened in this area. Therefore, we recommend that a cantilever retaining wall be constructed to retain the embankment in the western portion of the dam. The retaining wall should be provided with a vertical drainage mat (i.e., a geocomposite drain made with geonet and filter fabric) placed against the stem of the wall. A perforated drain pipe encased in drainage stone should be provided at the bottom of the drainage mat to carry the flow along the wall and discharge into the toe ditch. The drainage stone should extend along the entire heel width of the cantilever wall. The retaining wall should also be provided with weep holes for proper drainage and to prevent water pressure build-up behind the wall. Assuming an 11-foot tall retaining wall with a drainage blanket provided at the stem and heel of the wall, the following slope stability safety factors were obtained:
