Visual Dam Inspection and
Geotechnical Exploration Report
Review

Norman Road Dam

Clarkston Lake

CLIFS-18-GA-02795-01

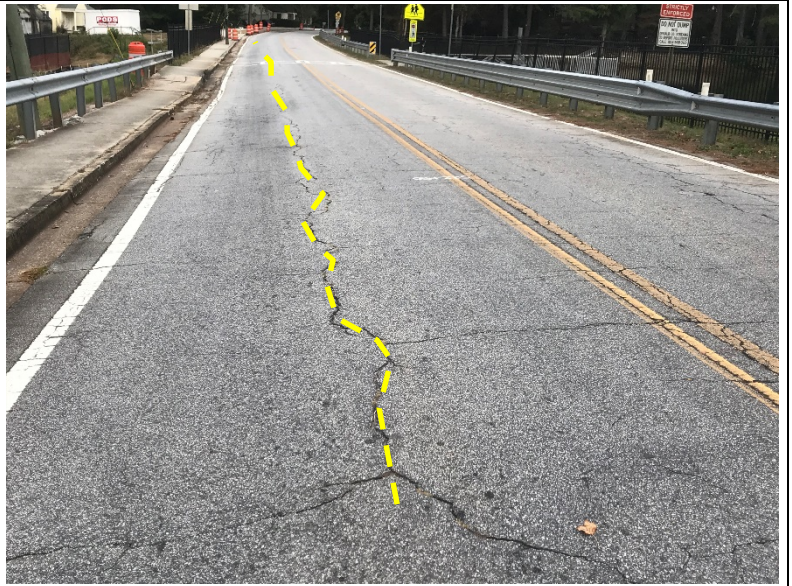
- Crest:
 - Norman Road is over the crest of the dam. The south lane shows pavement longitudinal cracking and settlement. The existing sidewalk on the south side of the road as well as the road concrete gutter show differential settlement and lateral movement towards the downstream slope (see Photos 1 to 4).

- 1.) Crest (Looking West) – Road Pavement Surface Cracking & Settlement; Poor Condition.

Road pavement surface over the dam has longitudinal cracks and settlement along the west to east traffic lane as well as settlement. The side walk and road drainage curb & gutter also show cracking and differential settlement. The dam crest is 30 to 35 feet wide.

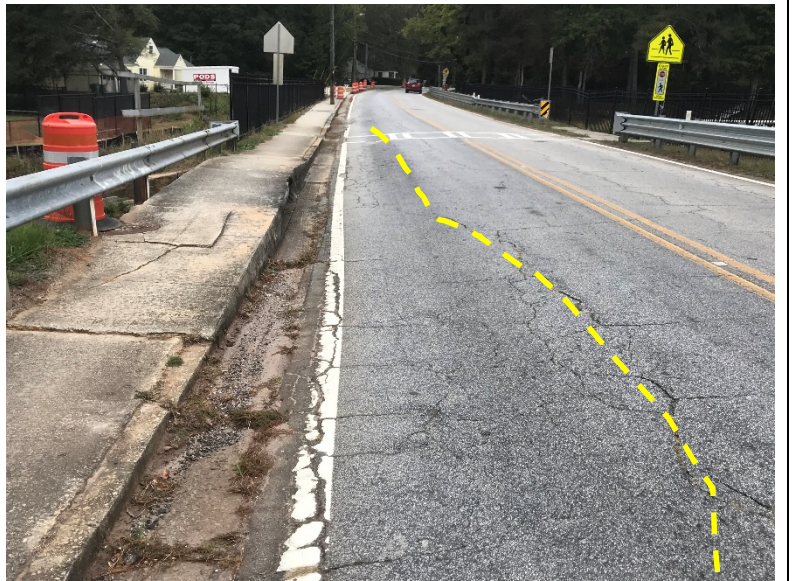
- 2.) Crest (Looking West) – Road Pavement Surface Cracking & Settlement; Poor Condition.

Road pavement surface area with longitudinal cracking and more pronounce settlement from about Road Sta. 521+00 to Sta. 522+25.

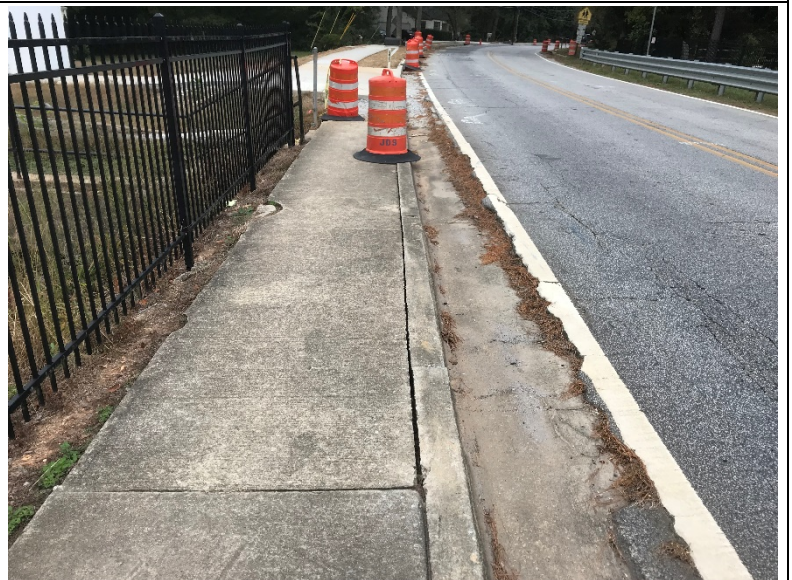
- 3.) Crest (Looking West) – Road Side Walk and Curb & Gutter Settlement; Poor Condition.

Side walk and curb & gutter show deferential settlement and translational movement towards the downstream slope near Road Sta. 520+75.

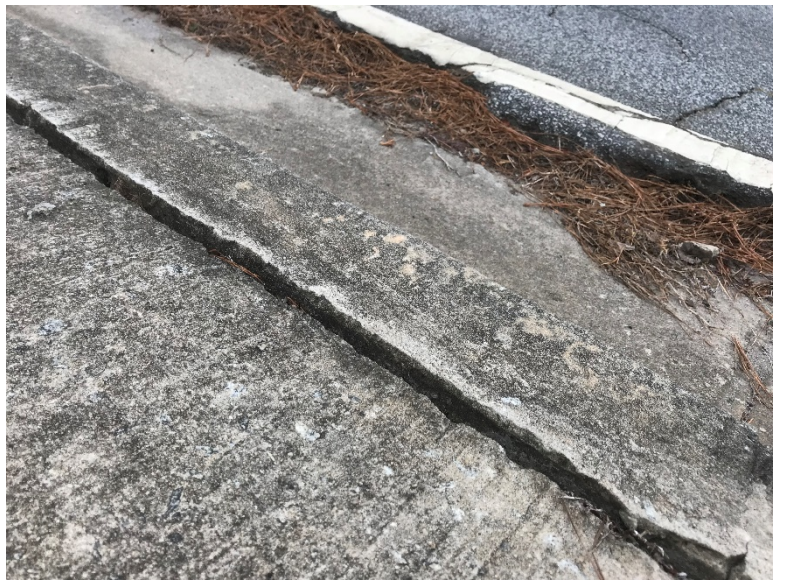
- 4.) Crest (Looking West) – Road Side Walk and Curb & Gutter Settlement;
Poor Condition.

Close up of side walk and curb & gutter showing differential settlement and translational movement towards the downstream slope near Road Sta. 520+75.

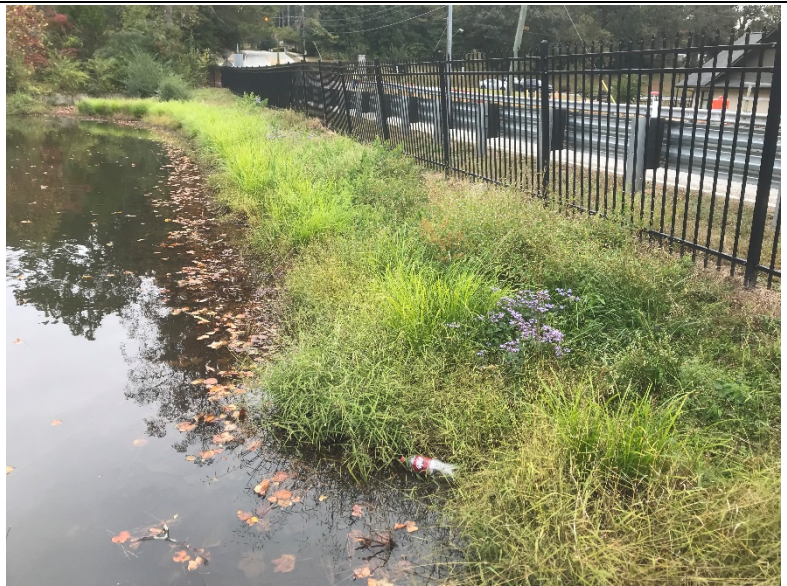
- 5.) Upstream Slope (Looking East) –
Vegetation;
Poor Condition.

The slope is overgrown and prevents proper inspection for animal burrows, depressions/settlement, and instability. The slope is approximately 3h:1v. Approximately 2.5 ft. of freeboard.

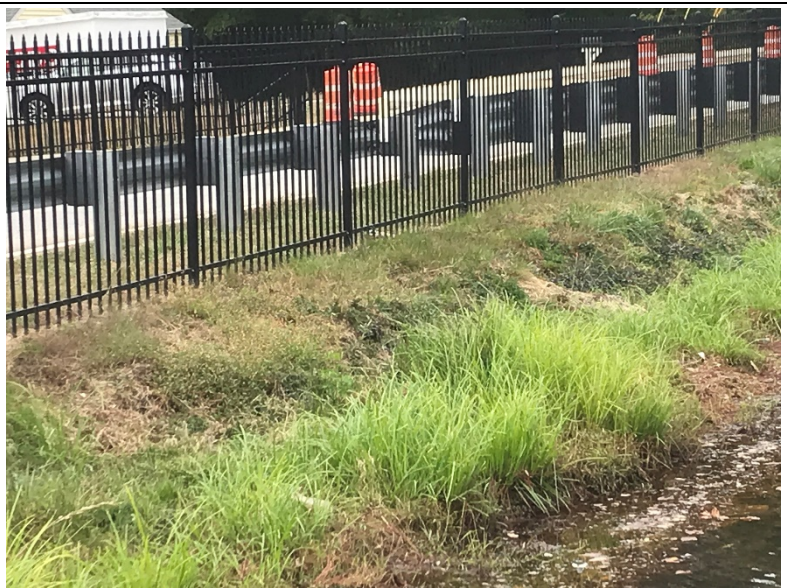
- 6.) Upstream Slope (Looking West) –
Vegetation, Instability;
Poor Condition.

The slope is overgrown along the shoreline and prevents proper inspection for animal burrows. The slope surface above the pool level is irregular and appears to show a scarp of historic movement/sloughing near the crest.

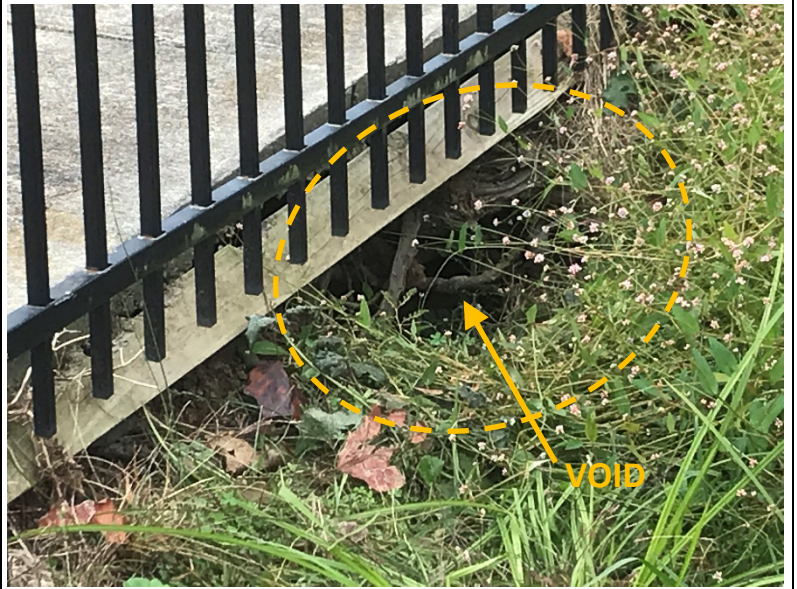
<p>4. Are there any depressions, bulges, ruts or holes (such as animal burrows) on the slope? If yes, describe (size, location, etc.):</p> <p>There was at least one hole noted under the side walk on the right side of the Dock. The hole may be associated with an animal burrow or erosion during overtopping events of the dam (two accounts during the last 8 years) (see Photo 7).</p>	<input checked="" type="checkbox"/> Yes <input type="checkbox"/> No <input type="checkbox"/> N/A
<p>5. Are there any eroded areas on the slope, i.e., wave erosion along the shoreline? If yes, (describe size, location, severity, etc.):</p> <p>There is a scarp (about 1 ft. high) near the top of the dam on the right side of the dam (right side of dock). The scarp (vegetated) may be associated with wave action erosion (beaching) or historic sloughing developed during dam overtopping events. The current pool level is about 0.5 ft. to 1 ft. below the original 12" to 18" CMP grouted riser and below the scarp (see Photo 6).</p>	<input checked="" type="checkbox"/> Yes <input type="checkbox"/> No <input type="checkbox"/> N/A

- 7.) Upstream Slope (Looking West) –
Animal Burrows and/or Undermine;
Poor Condition.

The side walk along the upstream slope has a localized undermined area or animal burrow just west of the lake dock.

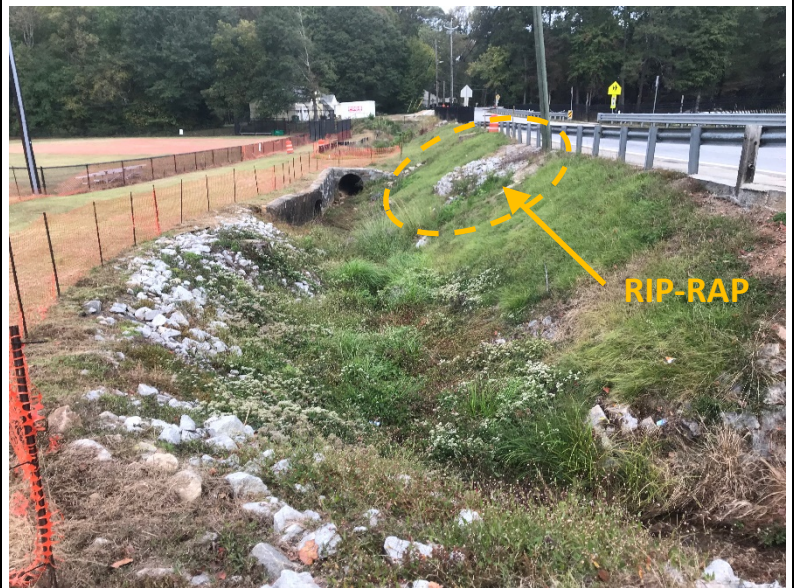
- The right (west) end area of the downstream slope is very steep (0.5H:1V). There is a retaining wall that shows damage/movement, some hand placed bricks/pavers have been placed to provide some support to the retained soils. As indicated above, slope stability needs to be checked and if necessary provide slope stabilization to obtain the required minimum factors of safety indicated above (see Photos No. 8 to 11).

- 8.) Downstream Slope (Looking West) –
Vegetation & Instability;
Poor Condition.

The downstream slope has overgrown grassy vegetation and is locally steep that prevents for proper inspection for animal burrows and wet/seepage areas, including area near the toe/drain channel. The slope varies from 1h:1v to 2h:1v.

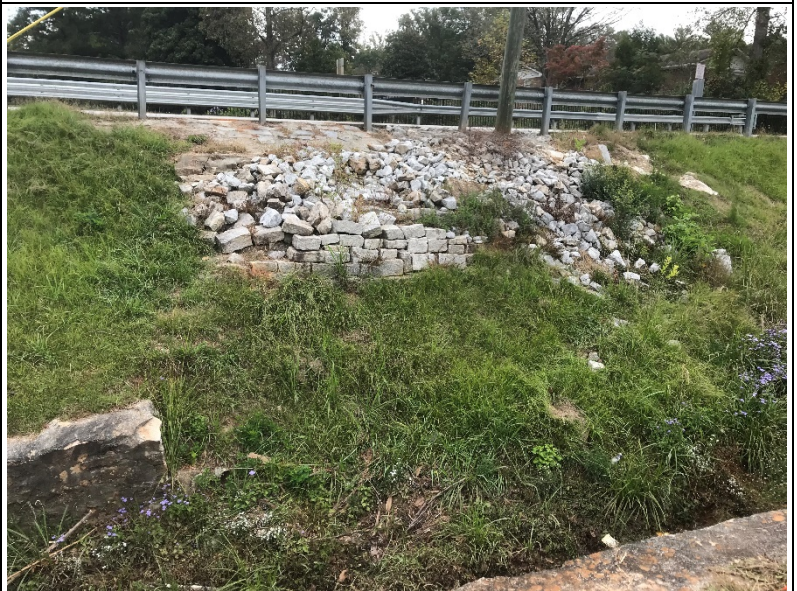
- 9.) Downstream Slope (Looking North) –
Instability;
Poor Condition.

The east slope (left slope) shows an area that has been stabilized with rip-rap and grouted pavers near the crest.

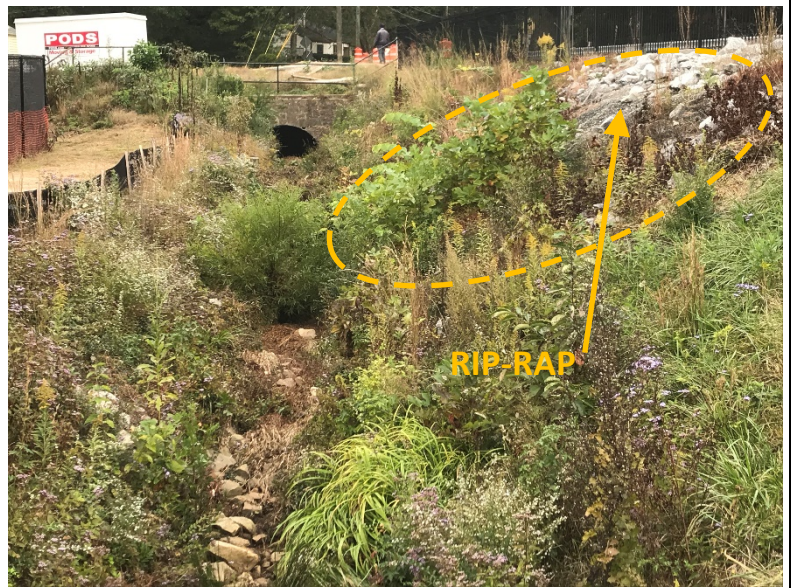
10.) Downstream Slope (Looking West) – Vegetation & Instability; Poor Condition.

The downstream slope has overgrown grassy and shrubby vegetation preventing proper inspection for animal burrows, wet/seepage areas, instability and erosion. The slope varies from 0.5h:1v (west end) to 2h:1v.

The west slope (right slope) shows an area that has been stabilized with grouted rip-rap from the crest to near the toe of the slope.

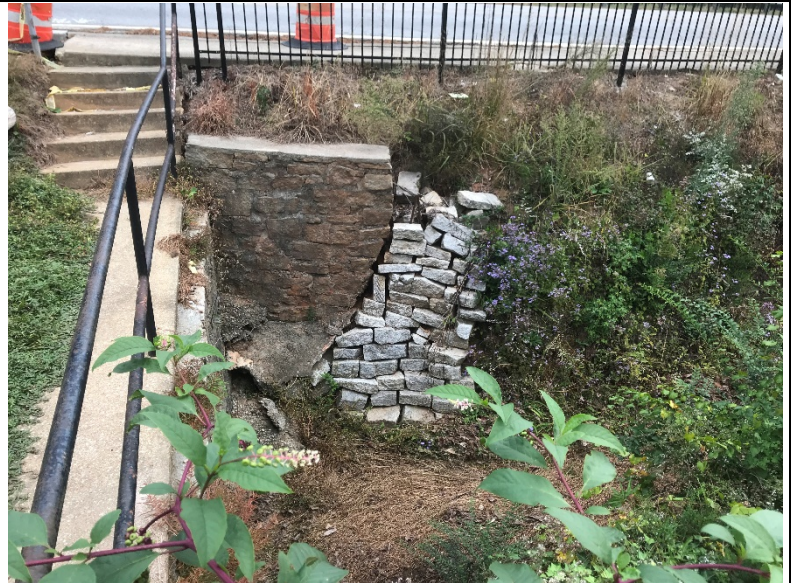
11.) Downstream Slope (Looking North) – Steep Slope & Retaining Wall Stability; Poor Condition.

There is a retaining wall at the west end (right side) of the downstream slope and channel running along the toe of the dam that is damaged; some stone blocks have been placed (not cemented) to provide some lateral support to the retain soils/slope. The slope is overgrown and prevents proper inspection. The downstream slope in this area is steep at about 0.5h:1v slope.

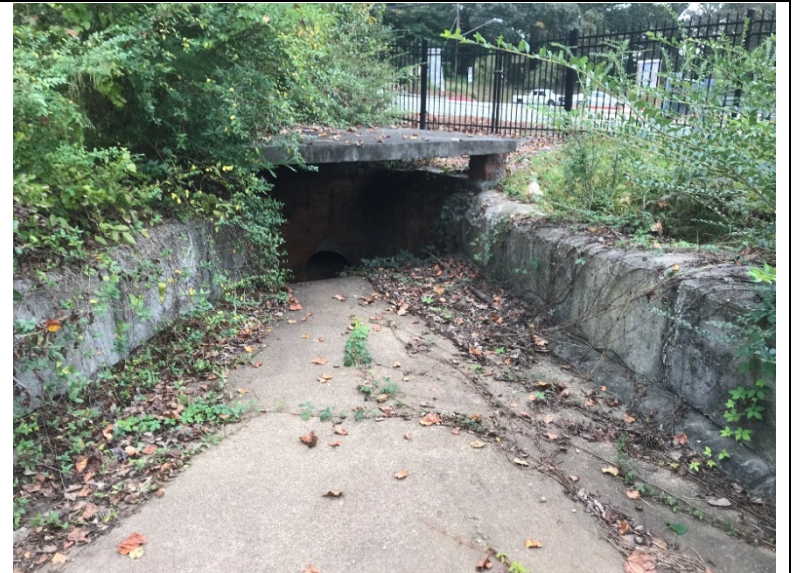
- Principal Spillway System:
 - During the visual inspection, water was not flowing over the principal spillway system approach concrete flume. Water was discharging into the spillway inlet structure below the concrete flume through an opening (brick missing) in the inlet wall. We recommend evaluating the source of the water and if the concrete flume has been undermined, backfill (grout) the void and re-establish flow over the spillway concrete flume. Two other pipes (an 18" RCP and a 24" CMP) also discharge to the inlet structure, there was no flow in these two pipes during the visual inspection (see Photos 12 and 14).

12.) Principal Spillway – Overflow Concrete Flume (Looking East) Poor to Fair Condition.

The concrete overflow flume leading to the overflow concrete inlet structure (OCS) looks in fair condition, however, water from the lake was not flowing over the concrete slab. The slab appears to be undermined and water is flowing under the slab (See Photo 13) into the OCS structure through an opening in the OCS brick wall. The flume is approximately 8 feet wide near the entrance, 6 feet wide at the OCS inlet and approximately 2 feet deep.

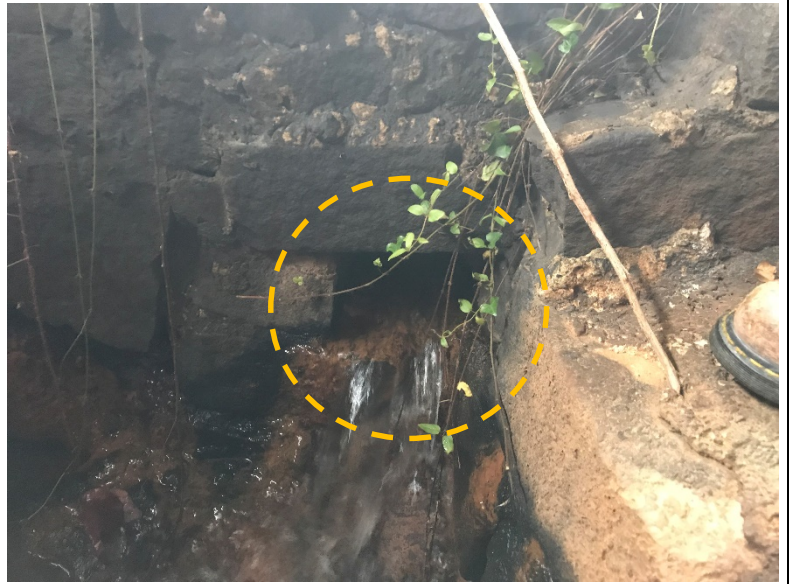
<p>13. For concrete channel spillways, are there any leaks or evidence of undermining (flow under the concrete)? If yes, describe (location, rate of flow from leak, indicators or undermining, etc.):</p> <p>See E.3 above (see Photo 13). Water is discharging at a rate of about 10 to 20 gpm (lake discharge base flow).</p>	<input checked="" type="checkbox"/> Yes <input type="checkbox"/> No <input type="checkbox"/> N/A

- 13.) Principal Spillway – Overflow Concrete Flume (Looking West)
Poor Condition.

Looking at water draining from the lake under the concrete overflow flume.
Flowing at an estimated 15 to 20 gpm.

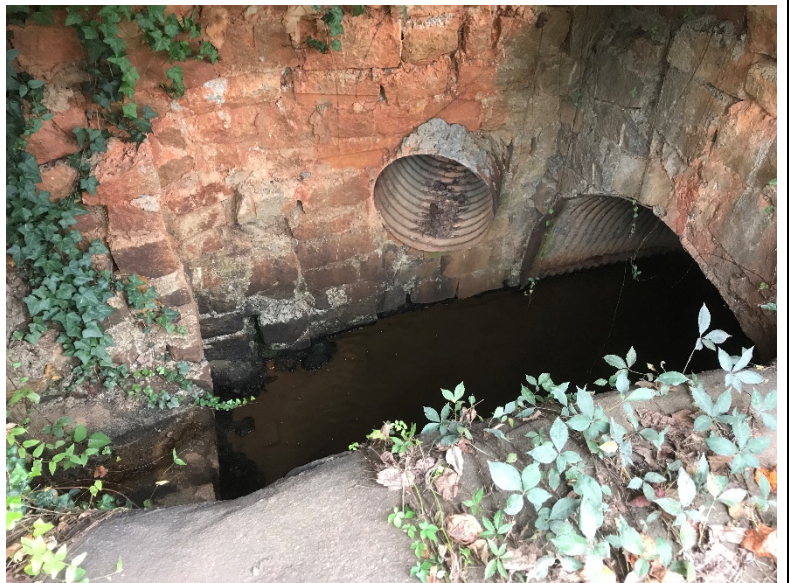
The concrete-lined approach flume leading to the OCS inlet is not obstructed. Water was not flowing over the flume at the time of the inspection. Water appears to be flowing under the concrete-lined flume as water was discharging below the flume discharge location through an opening in the OCS inlet wall (e.g. one brick missing) (see Photos 12 to 14).

- 14.) Principal Spillway – Overflow Concrete Structure (OCS) (Looking East)
Fair Condition.

Looking inside the OCS drop inlet. An 18" RCP pipe enters from the north side, a 24" CMP enters from the east, and the principal spillway pipe-arch 82" – 48" CMP pipe discharges to the south. The OCS drop inlet is approximately 5 x 7 feet in inside dimensions.

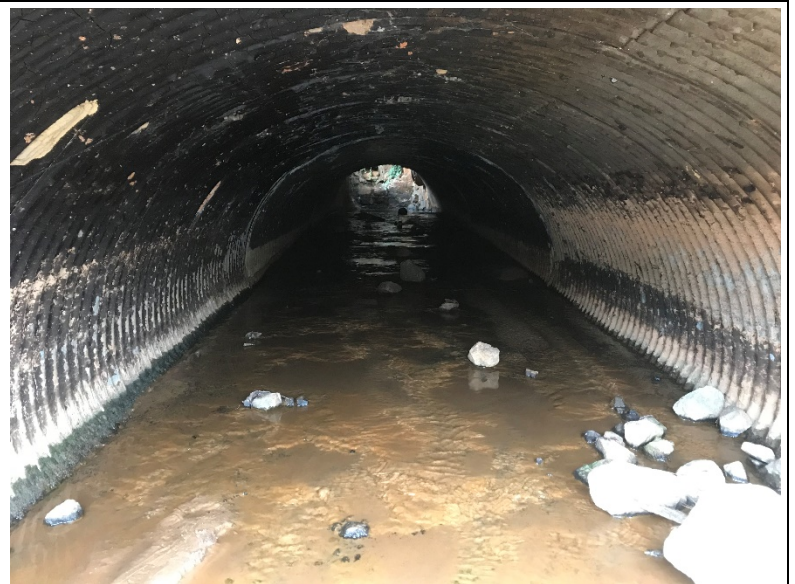
- The principal spillway pipe-arch CMP appears to be in fair condition with no indication of pipe deflection or corrosion of concern. Some sediment, cobbles and boulders were noted at the bottom of the pipe. Need obstructions at the bottom of the pipe including sediment and cobbles/boulders should be removed so the flow capacity of the pipe is not impacted (see Photos 15 and 16).

- 15.) Principal Spillway – Discharge Pipe-Arch 82" – 48" CMP (Looking North-Upstream)
Fair Condition.

Looking inside the 82" – 48" Pipe-Arch CMP. Some sediment and rock cobbles/boulders on the bottom of the pipe-arch. No evidence of pipe deformation or corrosion of concern noted.

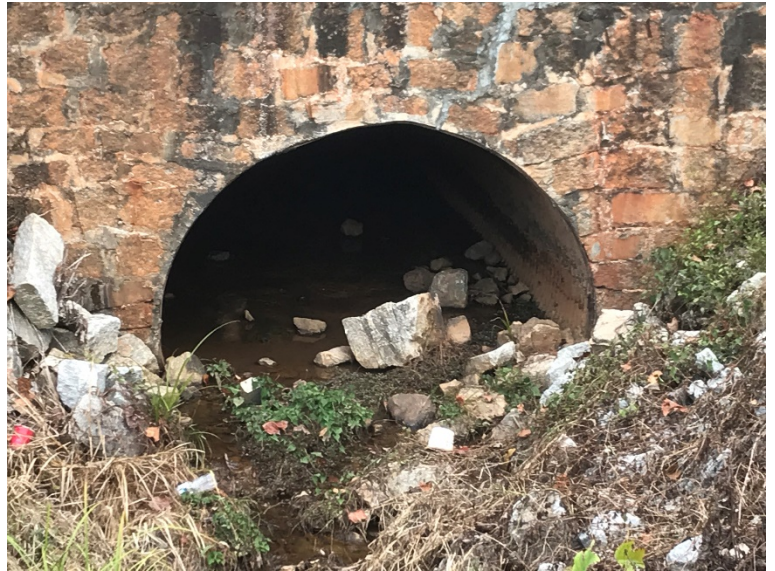
- 16.) Principal Spillway – Discharge Pipe-Arch 82”– 48” CMP (Looking North)
Fair Condition.

Looking at outfall of the Pipe-Arch 82” – 48” CMP. Some rock cobbles/boulders on the bottom of the pipe. No evidence of pipe undercutting or corrosion of concern noted. Discharge channel protected with rip-rap.

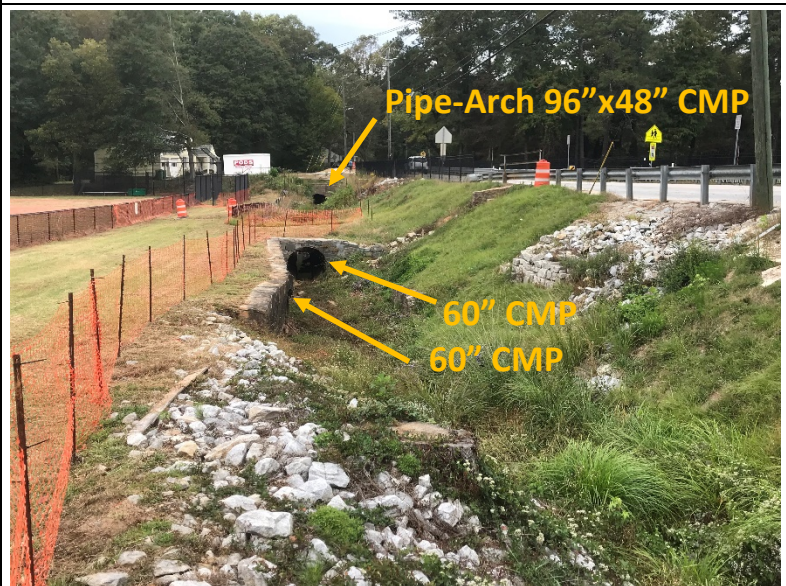
- 17.) Principal Spillway – Flow Away Channel/Toe Channel Erosion Protection (Looking North)
Fair Condition.

The flow away channel has overgrown grass which prevents proper evaluation for erosion and erosion protection. The toe channel appears to be lined with riprap along segments of the channel, if not all (covered with vegetation). A 60” CMP culvert is located halfway the flow away channel, and a 96” x 48” pipe-arch culvert is located at the far end of the open toe stream channel. Another 60” CMP drains out under the park ball field (See Photo 18).

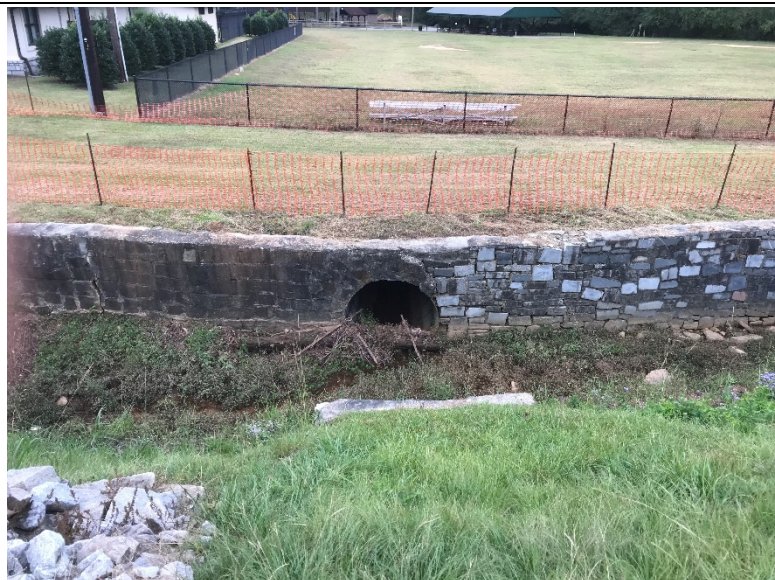
- 18.) Principal Spillway – Flow Away 60” CMP Culvert Under Park Ball Field (Looking South) - Obstructions
Poor Condition.

Inlet 60” CMP pipe partially discharging stream under the park ball fill. Pipe entrance is partially blocked with a fallen tree.

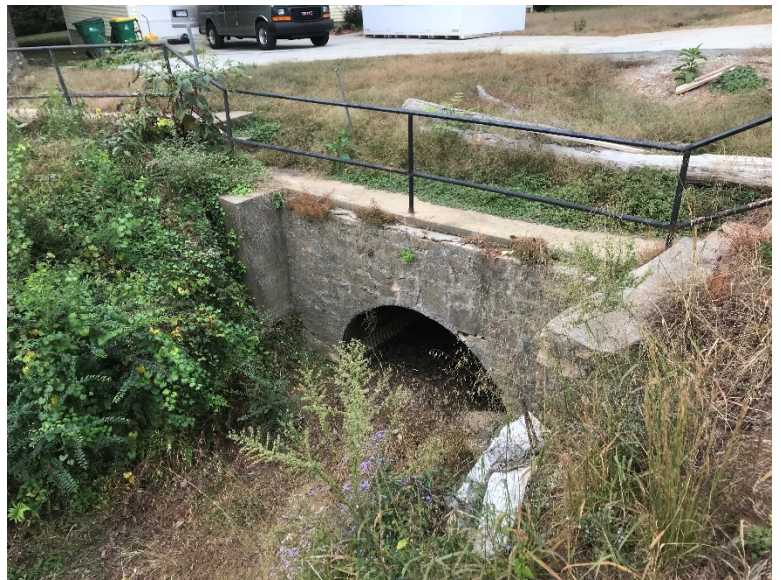
- 19.) Principal Spillway – Flow Away Pipe-Arch 96" x 48" CMP Culvert (Looking West) - Obstructions
Fair Condition.

Entrance of 96" x 48" Pipe-Arch CMP at downstream end of flow away channel along toe of dam downstream slope. Some sediment present at the bottom of the pipe.

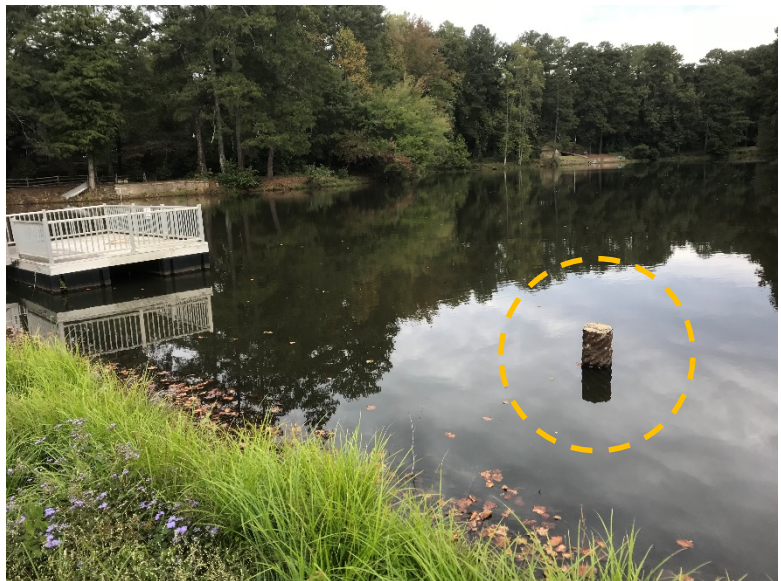
- 20.) Abandoned Principal Spillway 12" to 18" CMP Riser (Looking North)
Fair Condition.

An abandoned (grouted) 12" to 18" CPM Riser is located within the lake on the east side of the dam. An abandoned drainpipe outlet on the dam downstream slope could not be located during the visual inspection. The pool level was about 6" to 12" below the top of the abandoned CMP riser.

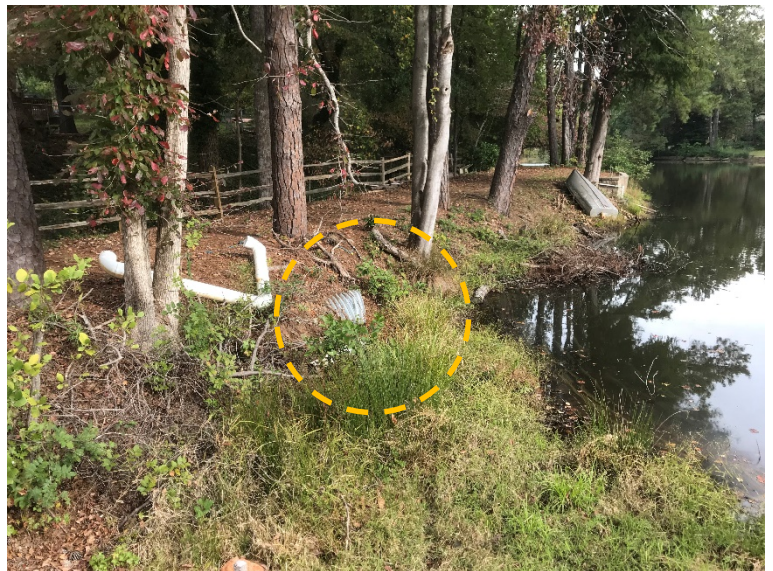
- Auxiliary (Emergency) Spillway System:
 - An auxiliary 24" CMP overflow pipe is located on the right dam abutment. This auxiliary spillway pipe appears to be the original pipe installed with the original 12" to 18" riser and drain pipe principal spillway system that has been abandoned. While this auxiliary spillway is functional, the base of the pipe at the outlet is corroded. This pipe could not be accessed for inspection due to the existing fence along Norman Rd. This pipe needs to be replaced (if needed) with a new pipe and properly sized for the dam spillway system to pass at least the 100-yr design storm event (see Photos 21 and 22).

- 21.) Auxiliary 24" CMP Spillway Pipe – Corrosion (Looking Northwest)
Poor Condition.

An auxiliary 24" CMP is located on the east side of the lake just north of the dam west groin. Access to the observe the condition of the CPM pipe inlet was not available at the time of the inspection (locked gate entrance).

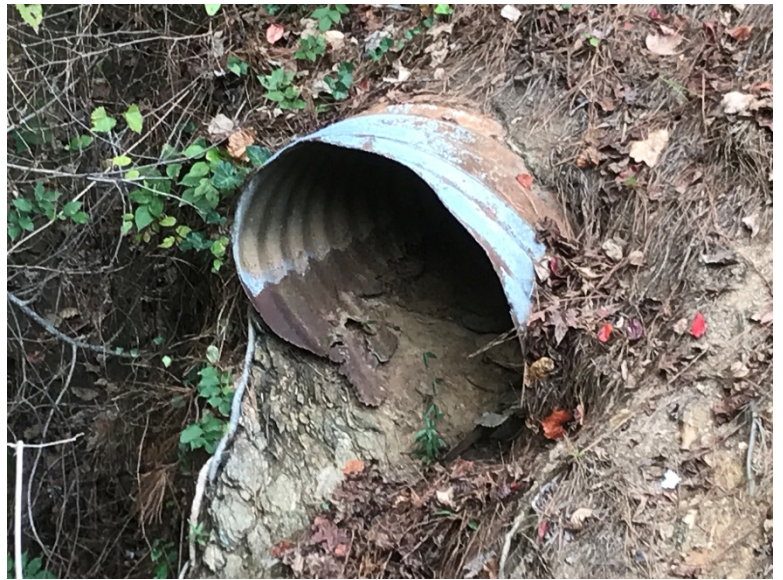
We understand the dam has overtopped two times during the last 8 years. Some erosion on the right side and outfall area of the concrete-lined flume has been stabilized with rip-rap. The 24" CMP auxiliary spillway outfall shows some erosion/undercutting, the pipe is corroded away at the bottom of the outfall. (see Photos 21 to 24)

- 22.) Auxiliary 24" CMP Spillway Pipe - Corrosion (Looking Northeast)
Poor Condition.

The auxiliary 24" CMP spillway pipe is corroded at the bottom of the pipe and shows some undercutting. The pipe discharges south into an earthen channel that drains into a culvert under Norman Rd.

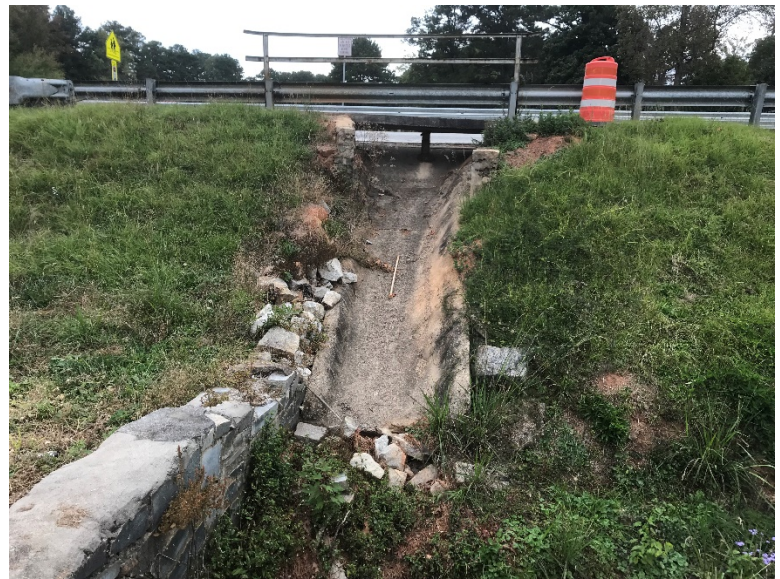
- In addition, a concrete-lined flume extends from the crest down to the toe of the downstream slope of the dam. This auxiliary spillway appears to serve as part of the emergency spillway system in the event that water overtops the dam during a heavy storm event. Some erosion on the sides and outfall of the concrete-lined flume has been repaired with small rip-rap. A construction joint or crack is located halfway down the concrete-lined flume. This joint shows some separation and movement down the slope. All cracks and joints need to be sealed to prevent water from entering the joint/crack and getting under the concrete slab (see Photos 23 and 24).

- 23.) Auxiliary Roadway Concrete Flume Spillway (Looking North) - Erosion
Poor to Fair Condition.

An auxiliary roadway concrete flume spillway is located over the downstream slope on the east side (left) of the downstream slope. Some historic erosion was noted on the west slope above the concrete flume and at the flume discharge point. Some small rip-rap has been placed to protect the eroded areas.

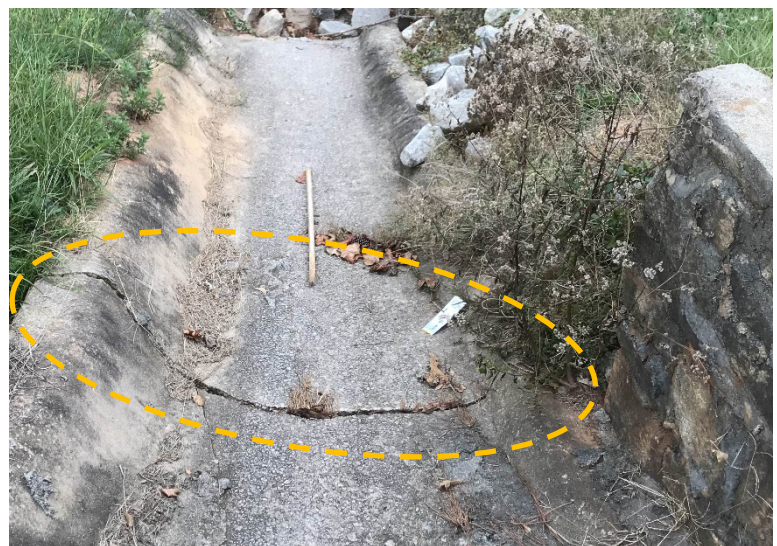
- 24.) Auxiliary Roadway Concrete Flume Spillway (Looking South) – Cracks
Poor Condition.

The concrete flume has a construction joint or crack down halfway the flume. The joint/crack shows some separation/movement down the slope.

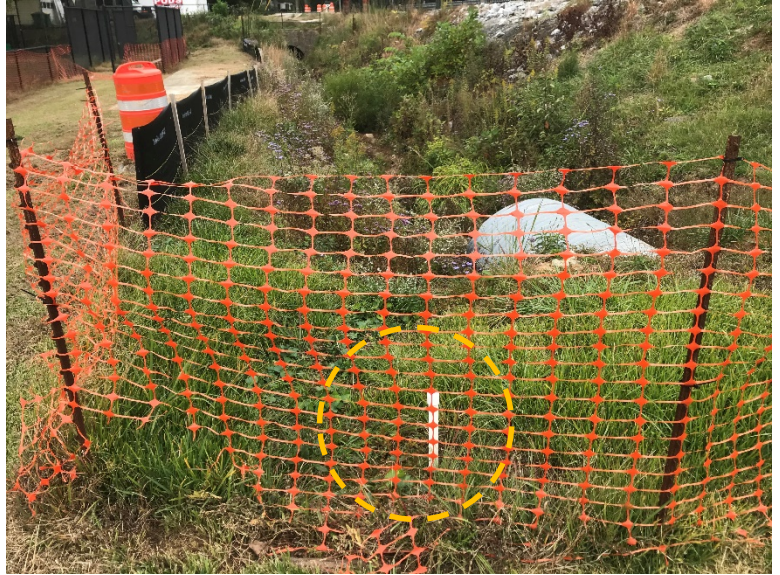
- Instrumentation and Monitoring Devices:
 - A number of temporary piezometers were installed during the geotechnical exploration completed by Willmer Engineering, Inc in 2014. Two 1" PVC piezometers were located during the visual inspection (B-6 and B-8). Other piezometers may have been abandoned or destroyed after they were installed. The two identified piezometers look in good condition. Water levels were not measured during the visual inspection (see Photos 25 and 26).

25.) Monitoring Devices – 1” PVC Temporary Piezometers (Looking North)
Fair Condition.

A 1” PVC temporary piezometer (B-6) located on the south side of the spillway channel (south of 60” CMP Culvert Area).

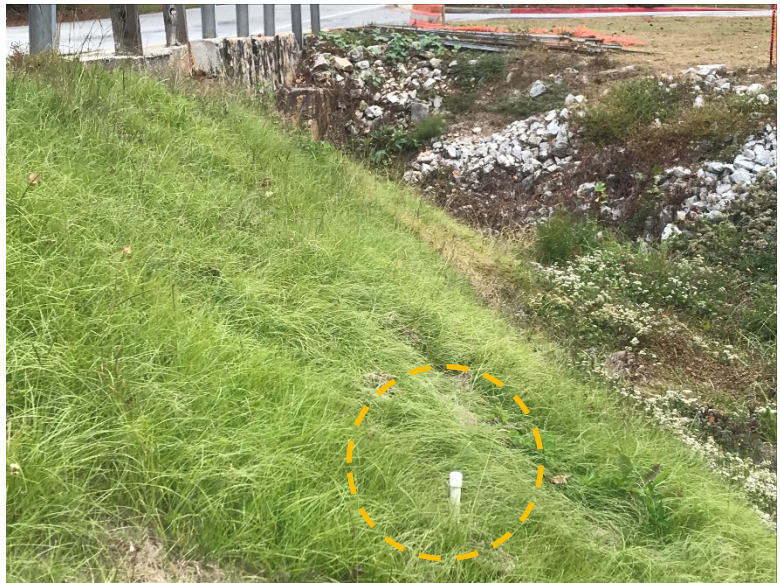
26.) Monitoring Devices – 1” PVC Temporary Piezometers (Looking North)
Fair Condition.

A 1” PVC temporary piezometer (B-8) located on the downstream slope on the east side (left side) of the dam.

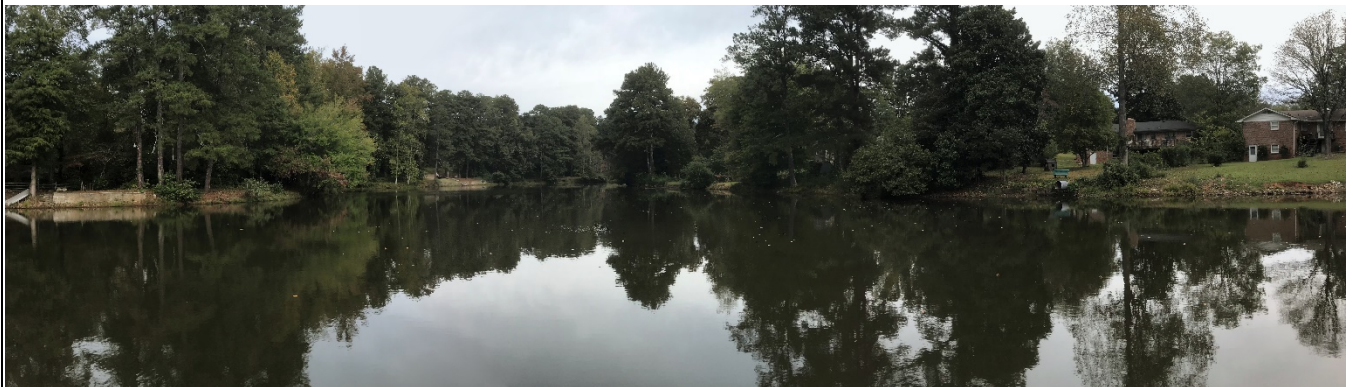
- Clarkston Lake:
 - The lake looks in good condition, no floating debris or dead trees or branches along the shore line were noted that may block the spillway system during large storm events. The lake should be Inspected periodically and remove any dead trees/branches along the lake shoreline that may block the spillway system (see Photo 27).

27.) Clarkston Lake – General View (Looking North) – Fair to Good Condition
