REPORT

Ground Penetrating Radar Survey
40 Oaks Nature Preserve House
3803 Market Street
Clarkston, DeKalb County, Georgia

RE: Ground Penetrating Radar Survey
40 Oaks Nature Preserve House Project Site
Clarkston, DeKalb County, Georgia
Project Number: CIOCL-24-GA-05308-02

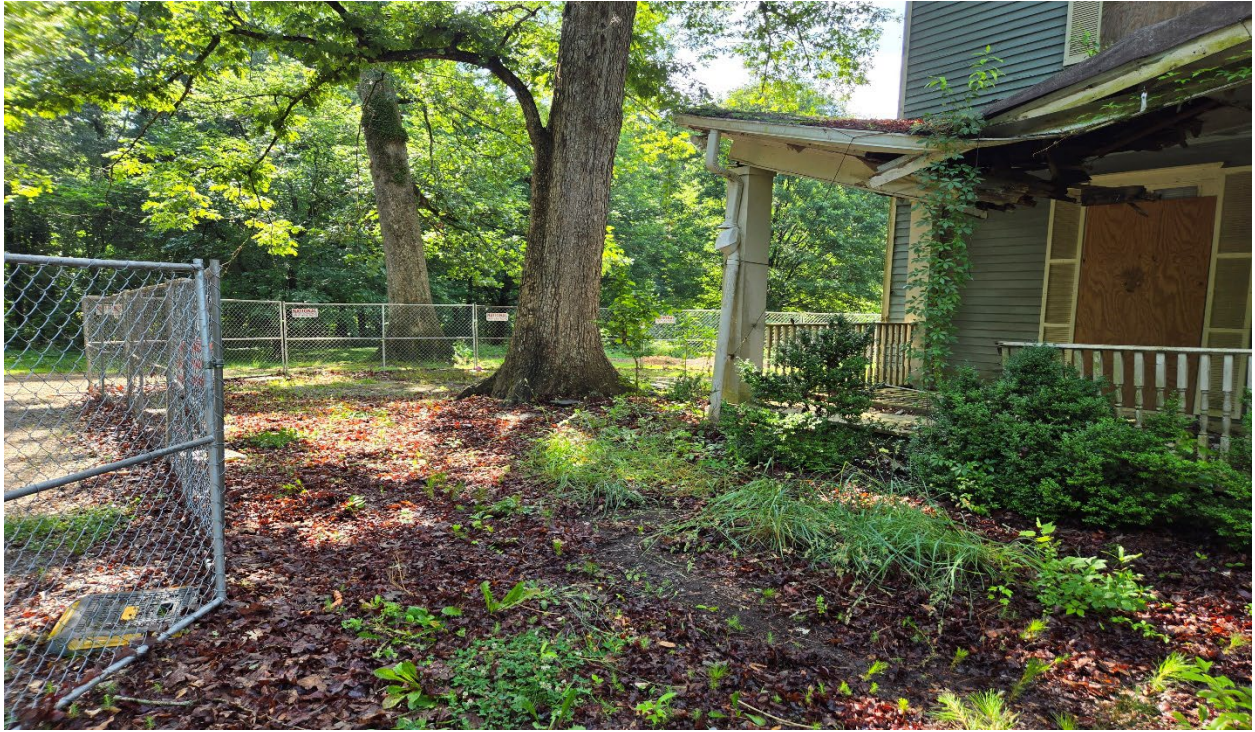
Figure 1: Photograph looking east across the north side of the farmhouse, inside the fence.

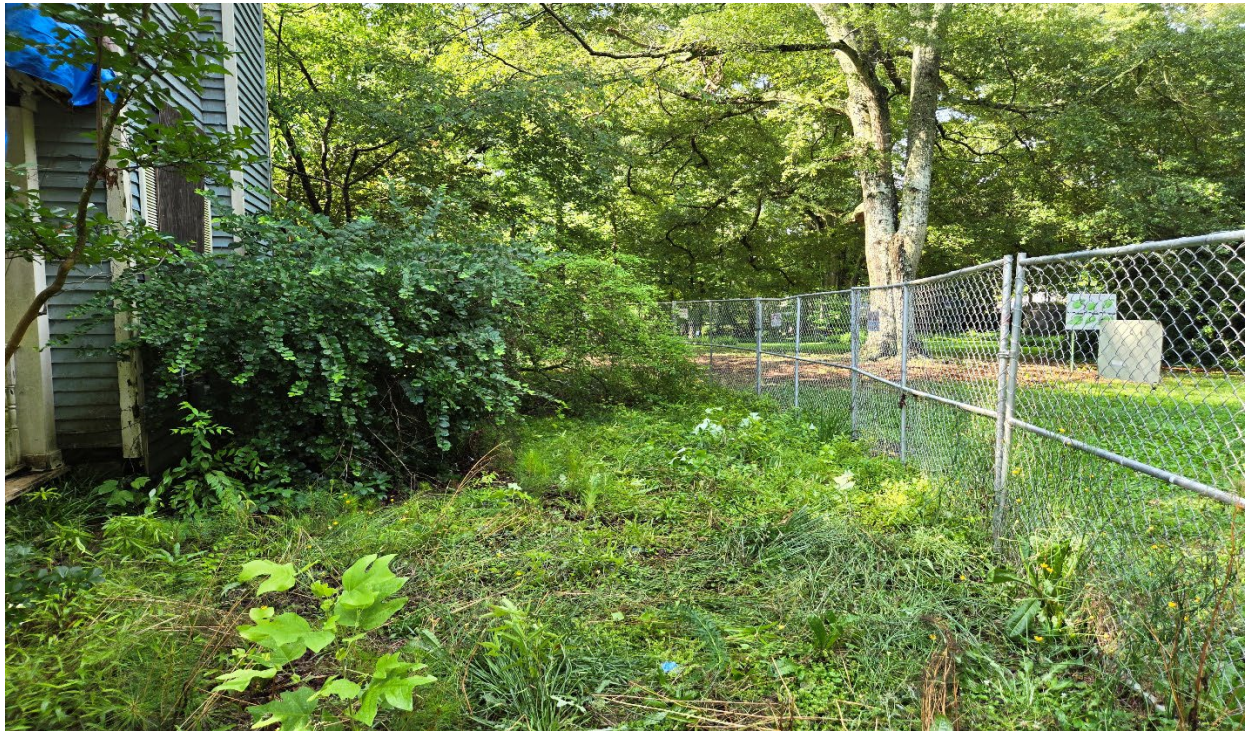
Figure 2: Photograph looking south across the west side of the farmhouse, inside the fence.

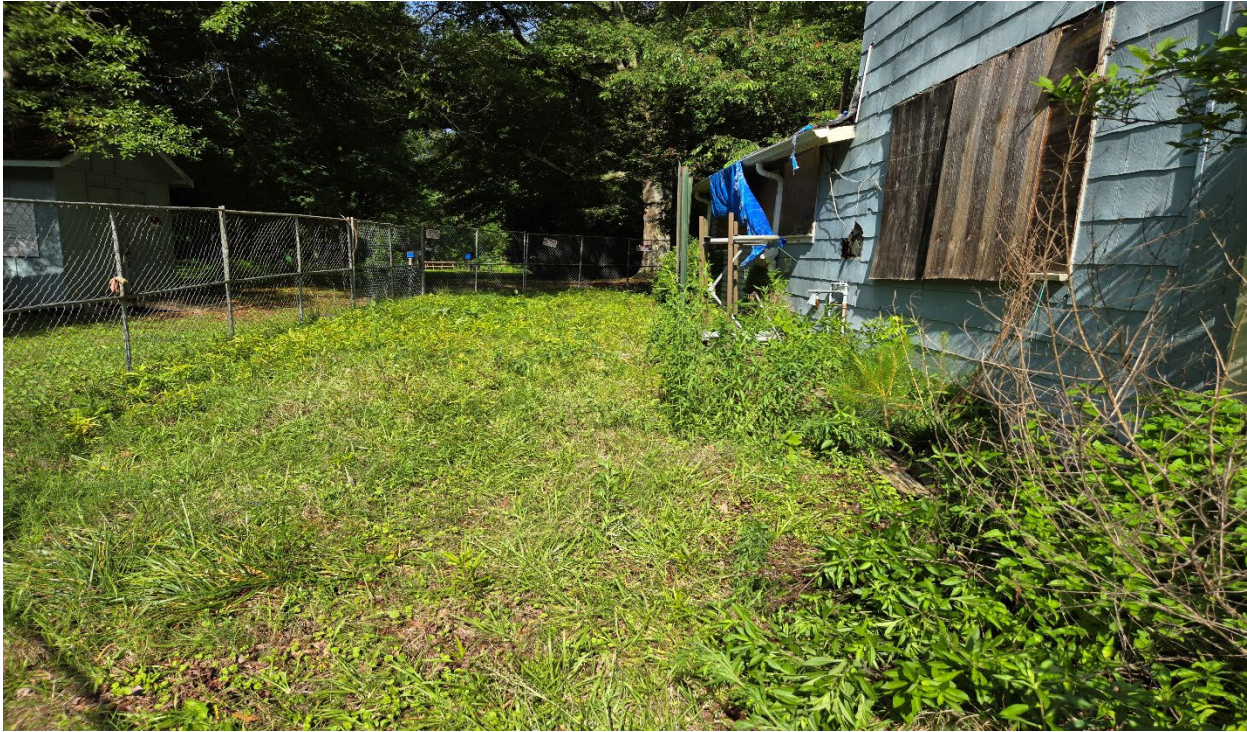
Figure 3: Photograph looking west across the south side of the farmhouse, inside the fence.

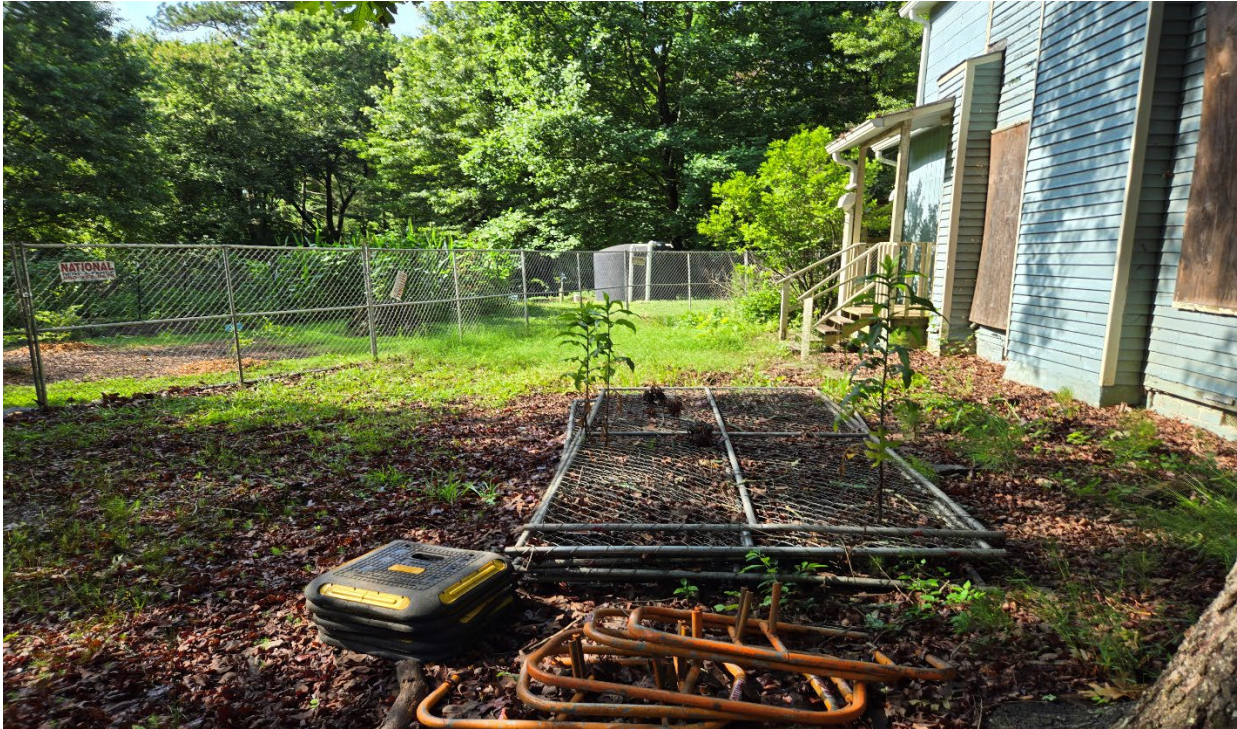
Figure 4: Photograph looking south across the east side of the farmhouse, inside the fence.

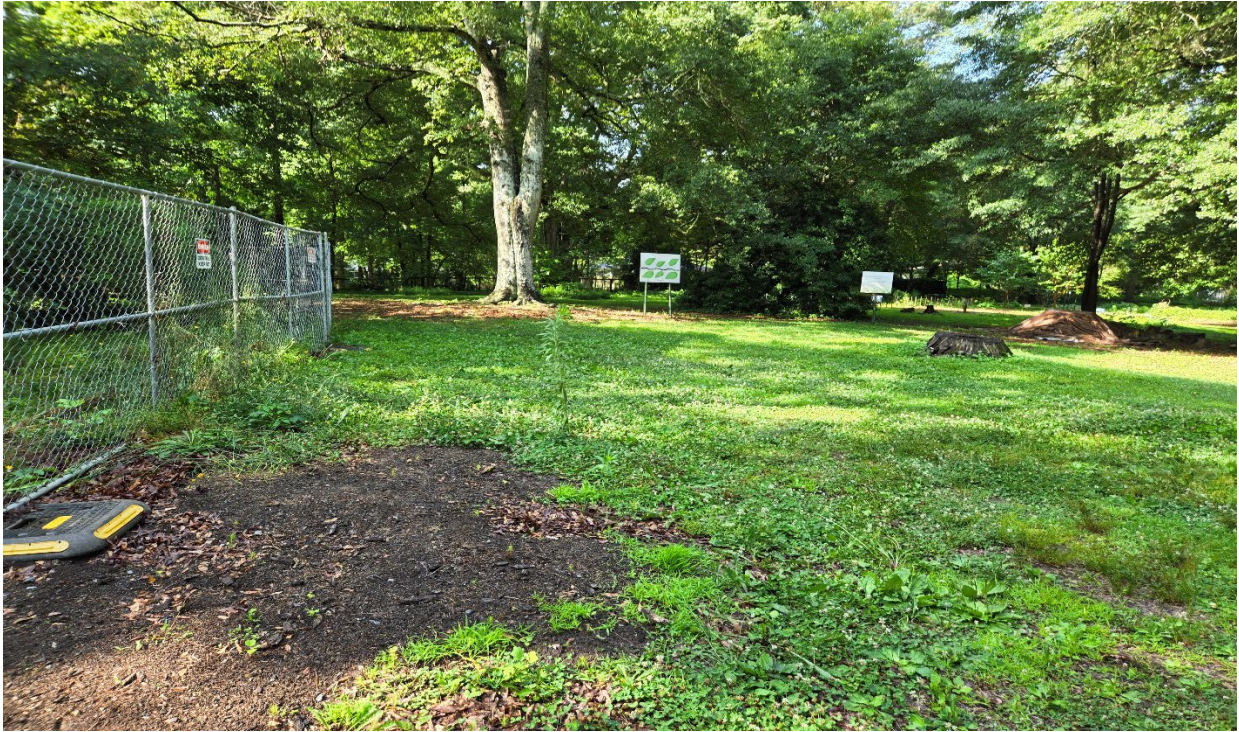
Figure 5: Photograph looking south showing the small survey area west of the farmhouse, outside the fence.

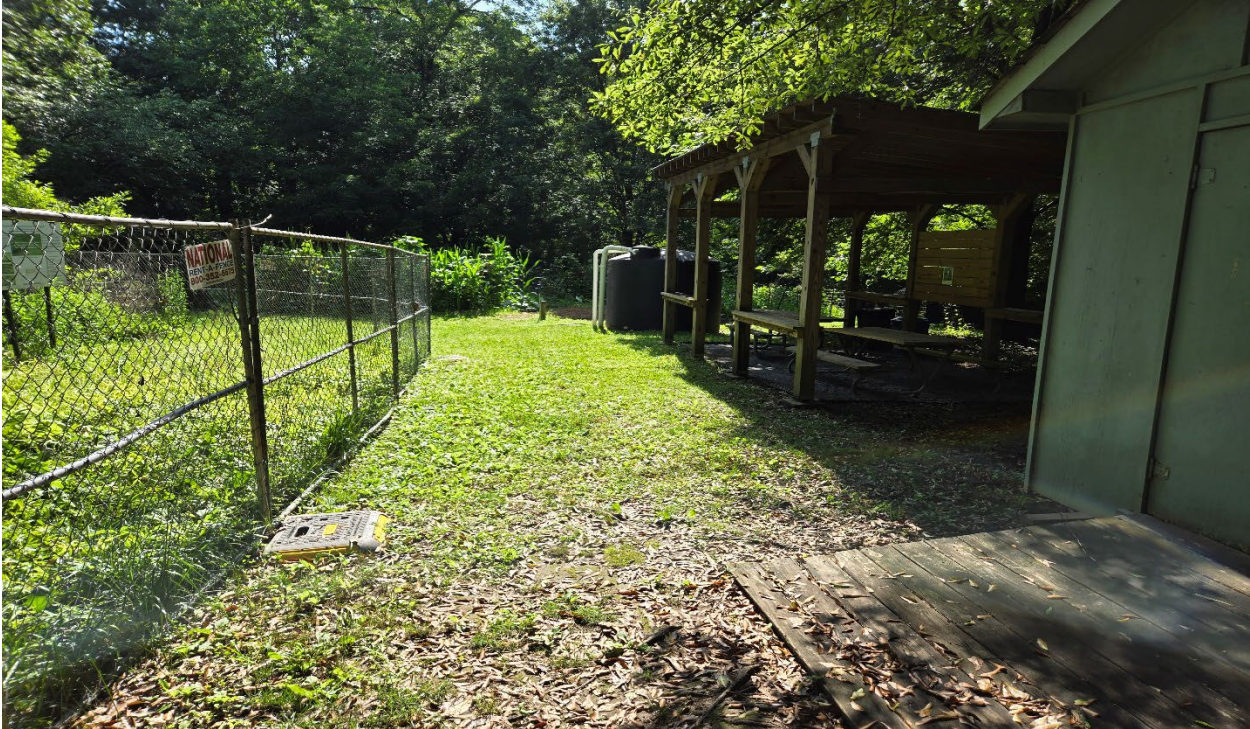
Figure 6: Photograph looking east showing the small survey area south of the farmhouse, outside the fence and near the water tank.

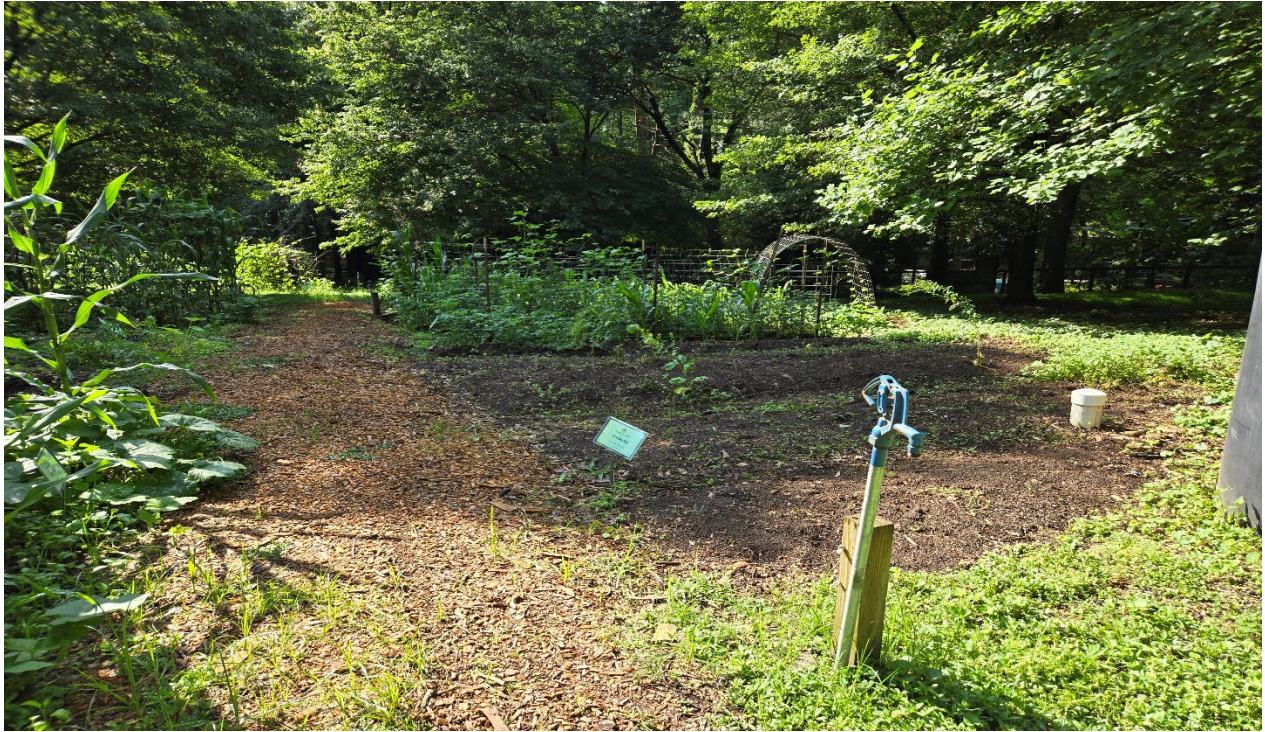
Figure 7: Photograph of the survey area near the water tank looking southeast.

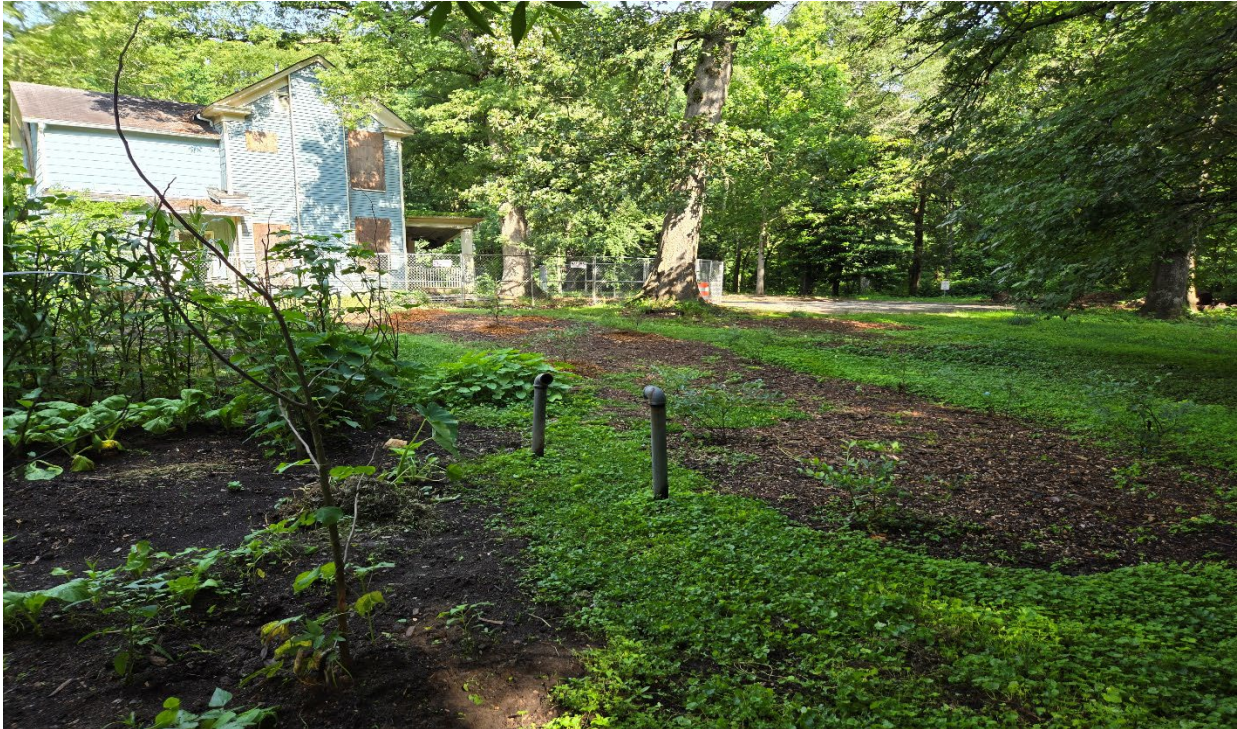
Figure 8: Photograph of the survey area near the two metal pipes in the garden east of the farmhouse.
