EXHIBIT B-1

MEMORANDUM							
TO:	Alok Pandya, P.E.	DATE:	September 7, 2018					
COMPANY:	Brown & Caldwell	SUBJECT:	Norman Road Dam, Milam Park, Clarkston, GA – Geotechnical Memo (DeKalb County Project #5)					
ADDRESS:	990 Hammond Drive, Suite 400 Atlanta, GA 30328	PROJECT NAME/NO.:	Dekalb Co. Gravity Sewer Rehabilitation, Replacement, and Construction 18C17041.00					
FROM:	J. Ryan Collins, P.E & Graham Elliott, P.E.	CC:	Jesse Brown (Brown & Caldwell)

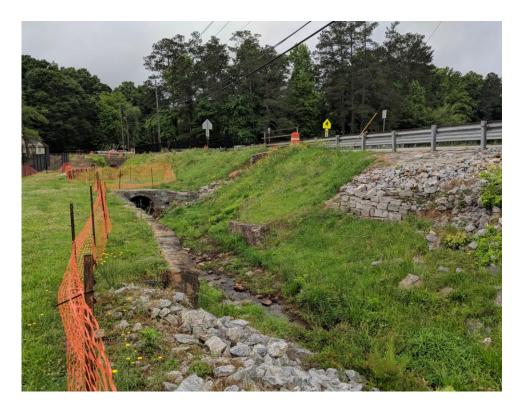
Downstream slope of dam with partial placement of rip rap stone. Note water flow at toe of slope and bowed alignment of retaining wall near orange barrier fence.

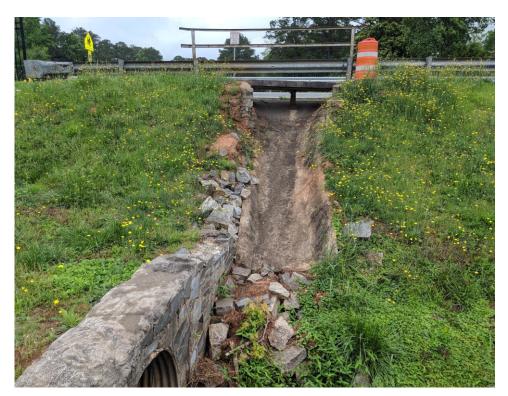
Concrete lined chute in the downstream slope of dam to convey storm water from inlet on Norman Road. Note bottom of chute is blocked with loose rip rap, and vegetation. Note headwall and corrugated metal pipe (CMP) conduit at toe of downstream slope of dam.

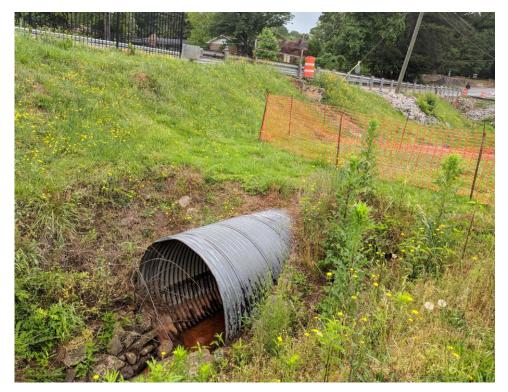
Corrugated metal pipe (CMP) conduit aligned parallel with toe of the downstream slope of the dam.

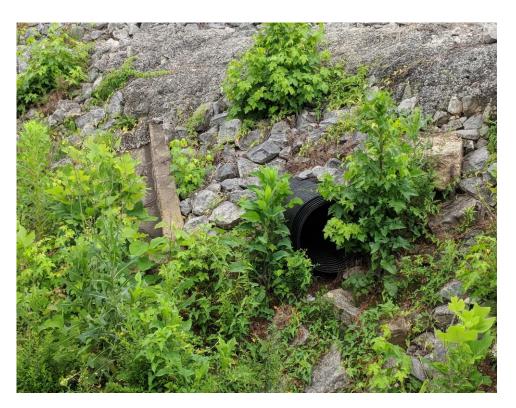
PHOTO NUMBER: 14

Corrugated plastic conduit in downstream slope of dam. Also note irregular coverage of loose rip rap and partial concrete veneer.

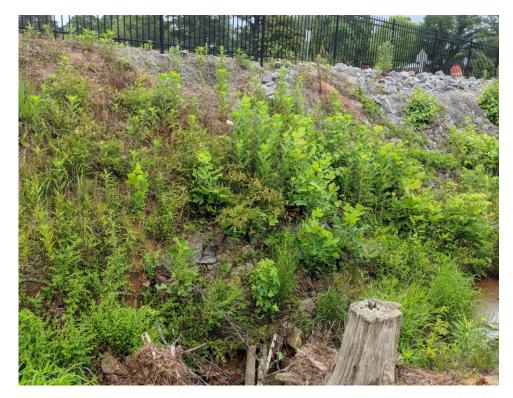
Downstream slope of dam, with vegetation growing through rip rap. Note water in toe ditch.

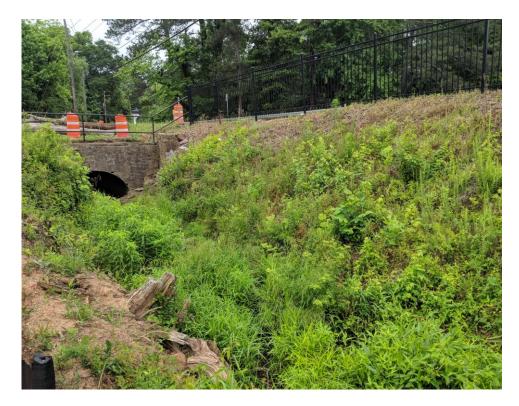
Overgrown ditch at toe of downstream slope, viewed

toward the west.

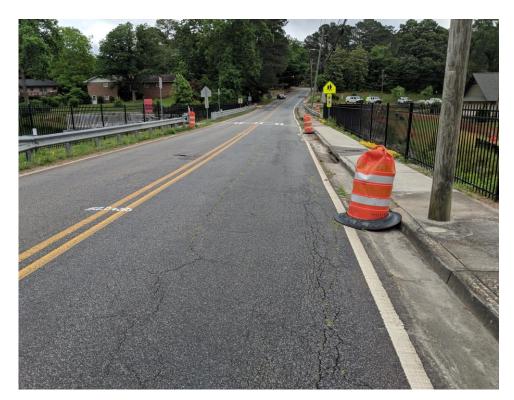
Longitudinal cracking in the asphalt pavement of Norman Road along the crest of the dam. View toward the west.

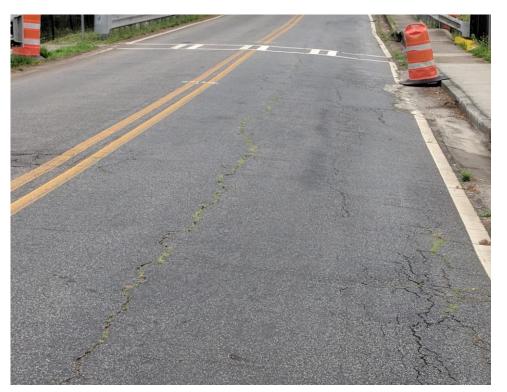
PHOTO NUMBER: 22

Longitudinal cracking in the asphalt pavement of Norman Road along the crest of the dam. View toward the west.

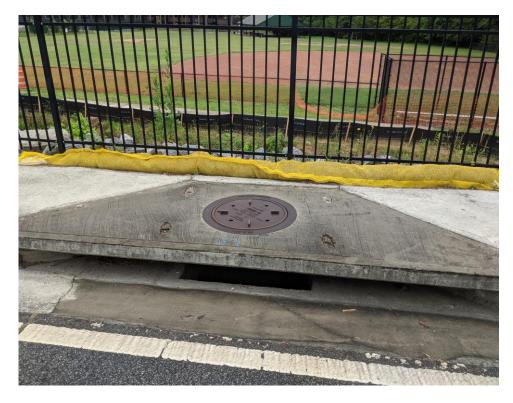
Stormwater inlet to concrete lined chute on the downstream slope fo the dam. Note temporary the straw wattle at rear of the concrete.

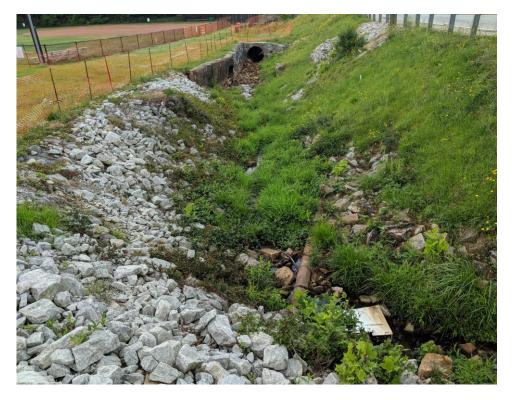
Exposed sewer line located immediately downstream of Norman Road Dam.

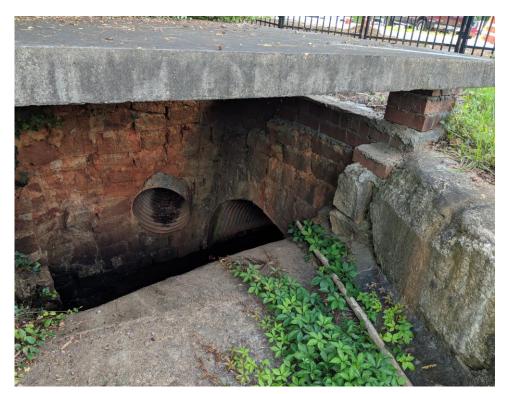
Drop inlet to spillway structure on upstream side of dam in the left abutment. Note CMP conduits.

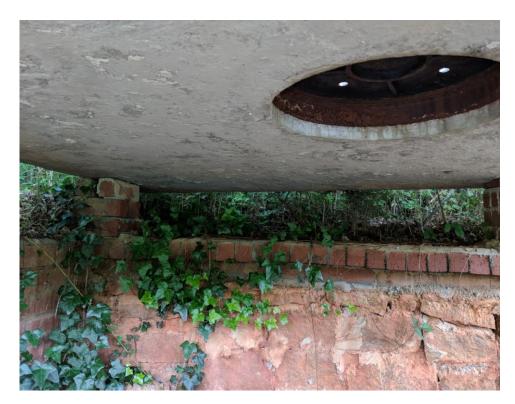
Soffit of the concrete slab atop the spillway structure. Note the lack of mortar in the brick pedestal.

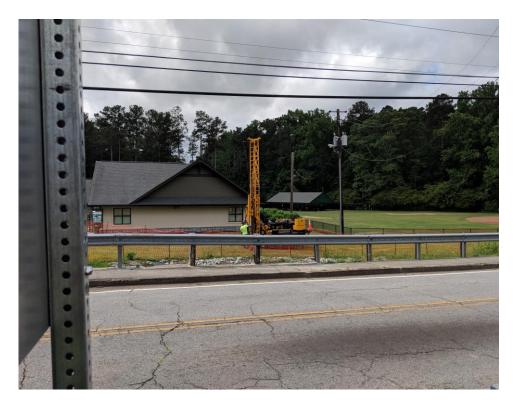
Transverse cracking in the asphalt pavement across the width of Norman Road.

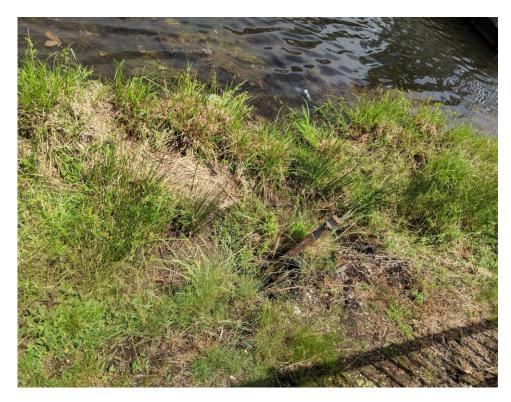
COMMENTS: Erosion feature in upstream slope of dam.
