# TREE PRESCRIPTION FOR: 3921 Church St, Clarkston GA

DATE	PROJECT NAME	PREPARED BY
11/6/2024	City Hall Sidewalk Repair	Alex Phillips MA-4868A
	Address: 3921 Church St Clarkston GA

This project is a sidewalk replacement in front of the Clarkston City Hall Building. A large 41" S Red Oak is cracking and heaving the sidewalk and a retaining wall. The curb along Church St will be repaired and lifted 6" to provide a physical barrier between cars and pedestrians. This lift will work well with the current elevation of the sidewalk and will help preserve roots growing under the sidewalk.

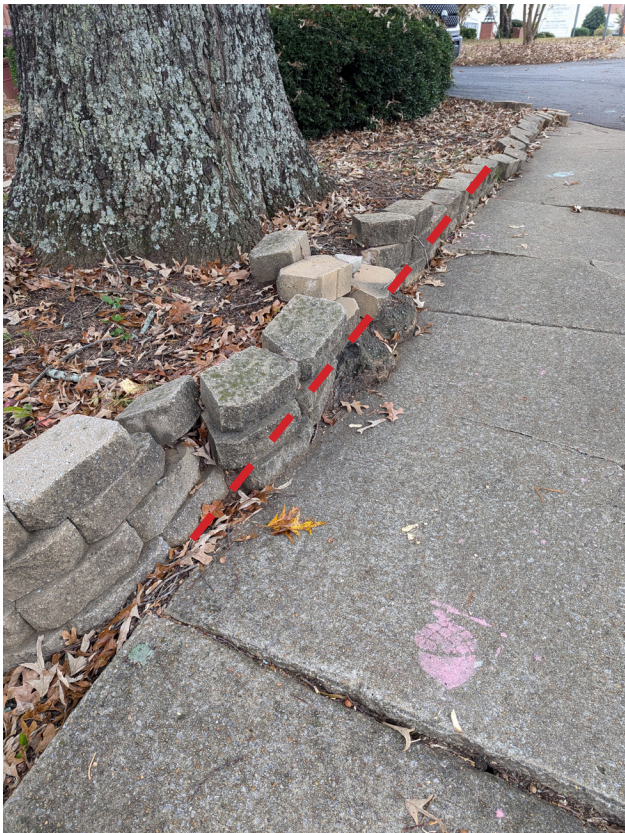
Pic 1: Location of root flare overgrowth. Shear cut here.

Tree	Prescription - All work to be completed by HAND
41" S Red Oak	<p>Sidewalk construction: Remove existing sidewalk. Shave overgrown root flair back to 4' from BOC. Pour pervious concrete on grade, NO EXCAVATION. Forms floating on grade. Where sidewalk is to be widened to five feet, scrape of duff and organic matter. Light excavation but try to keep all roots intact in these areas. Pour pervious concrete on grade as much as possible.</p> <p>For front walkway construction: Shift Walkway to the East 4' to avoid current root growth under the existing walkway. Where sidewalk is to be placed, scrape of duff and organic matter. Light excavation but try to keep all roots intact in these areas. Pour pervious concrete on grade as much as possible. Retaining wall to be rebuilt on grade, NO FOOTER and no excavation behind new wall location.</p>

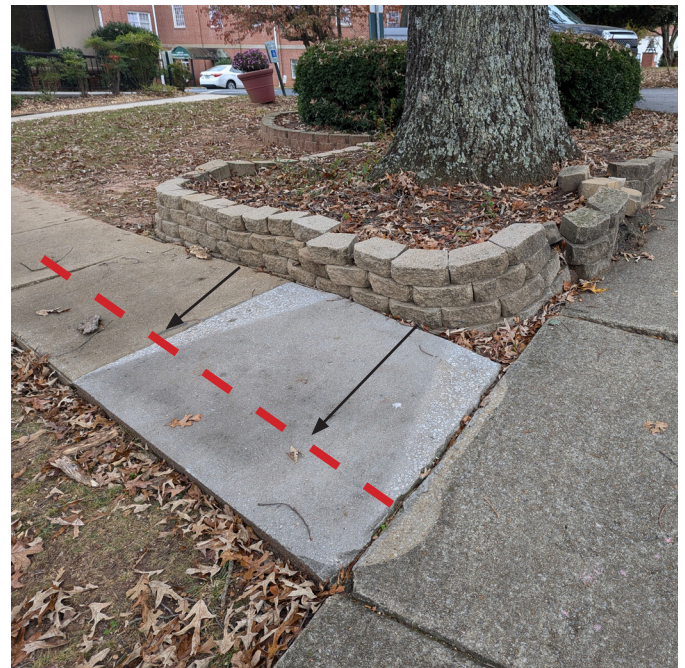
Pic 2: Shift walkway edge away from tree.
